## TITLE PAGES AND CONTENT

# **CLAY COUNTY COURTHOUSE OF 1884**

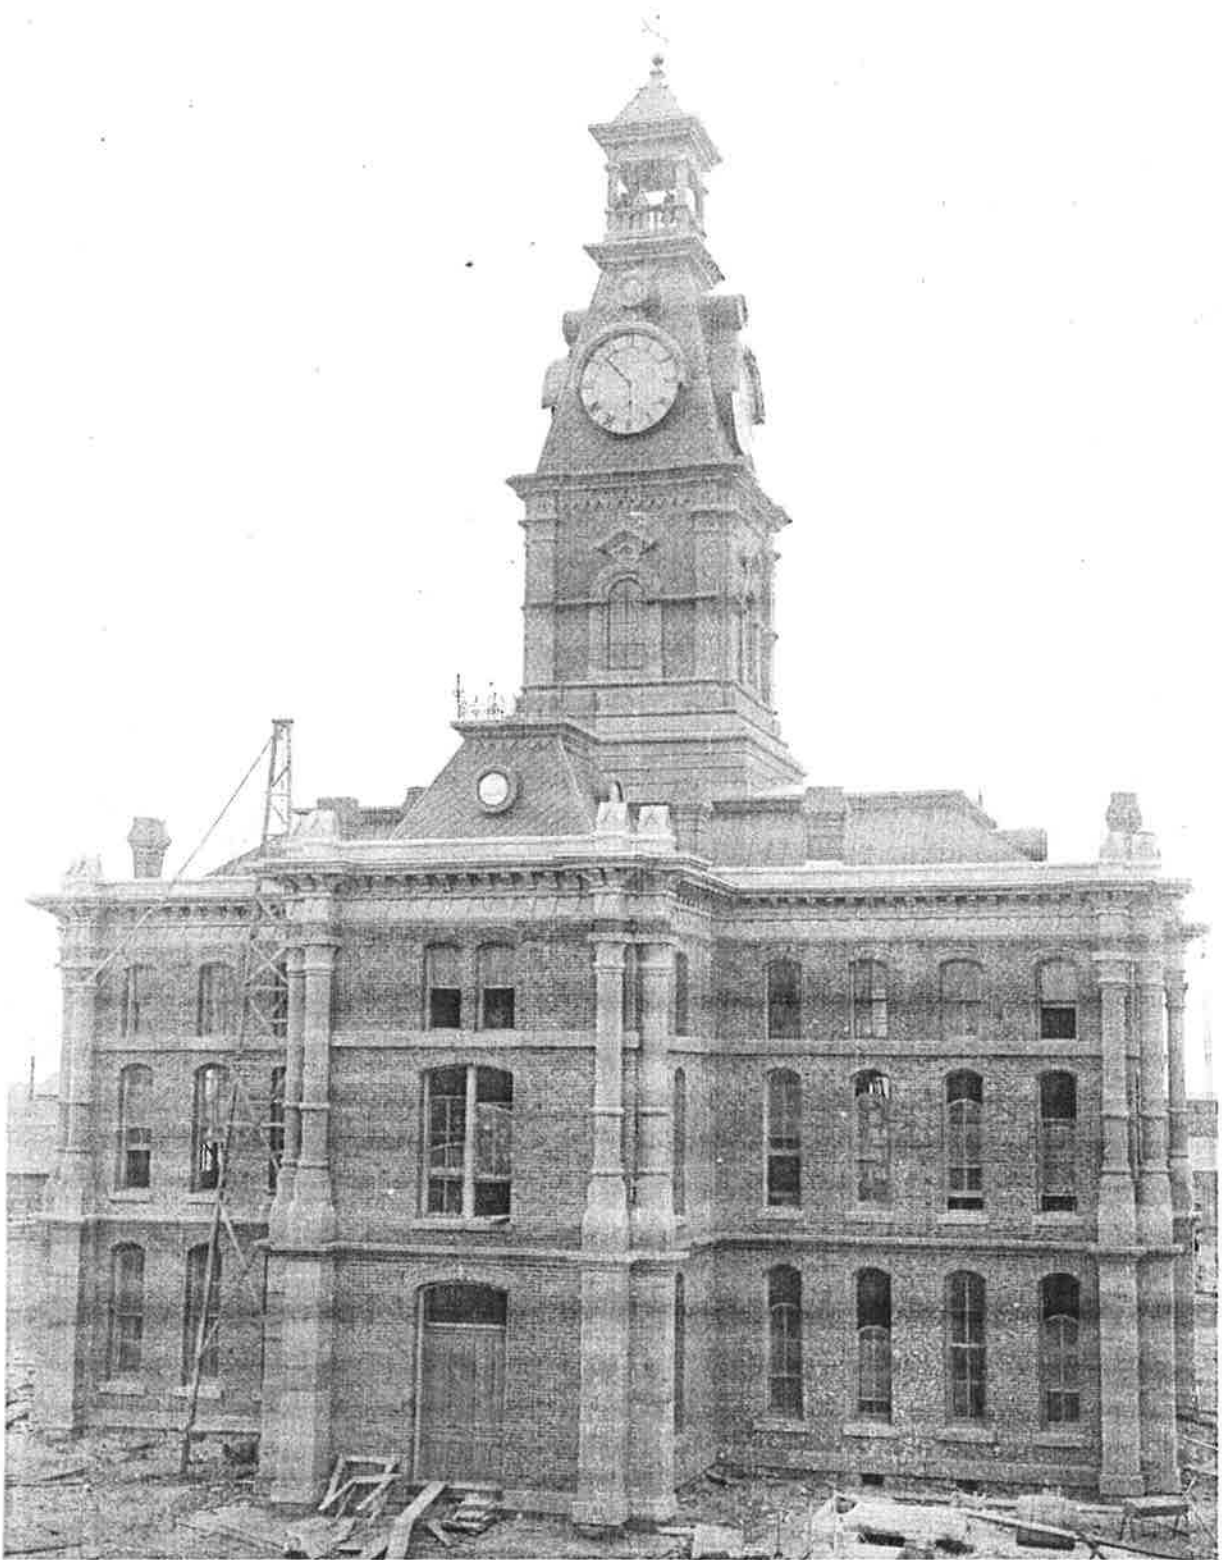
*FIGURE II-1. Images such as the one above are extremely rare. A photograph of this detail and clarity can almost single-handedly make full restoration of an historic building exterior possible. This image shows the north facade of the Clay County Courthouse as the building neared completion in 1885. Notice the three people standing in the cupola atop the tower.*

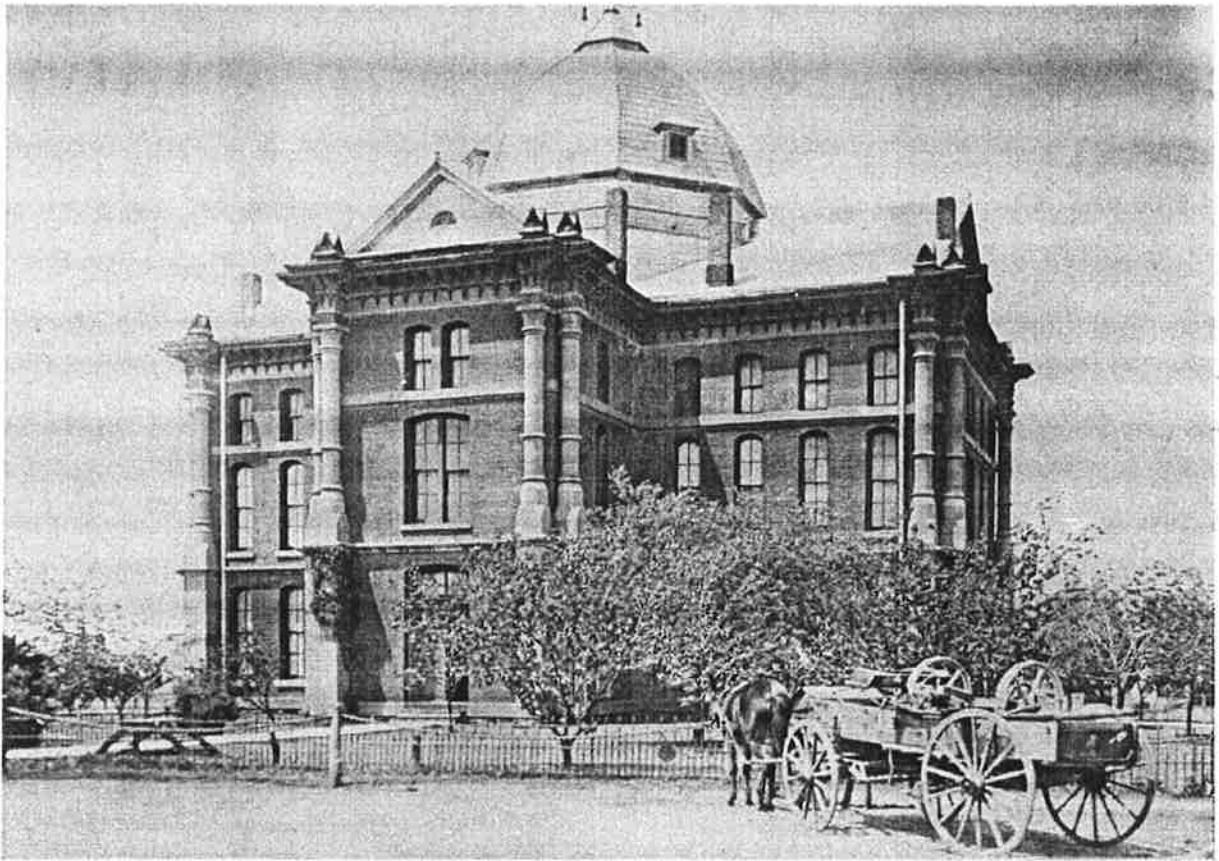
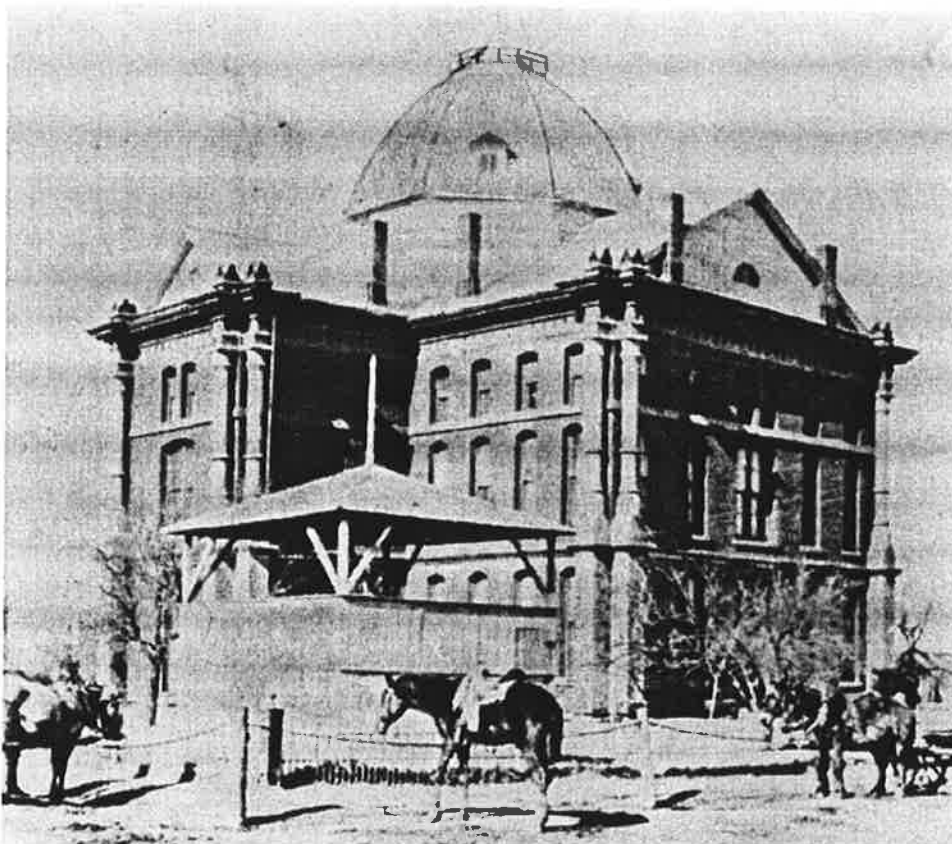
**FIGURES II-10 (ABOVE) AND II-11 (LEFT).** In 1912, the remaining portions of the original tower and roof were removed and replaced by the dome pictured above. Evidence discovered in the attic suggests that the roof was finished with metal shingles. Note that the roof drainage system has shifted from internal to external downspouts. The iron fence is still in place at this time. The lack of a railing around the widow's walk atop the tower suggests that Fig. 10 is slightly earlier than Fig. 11.

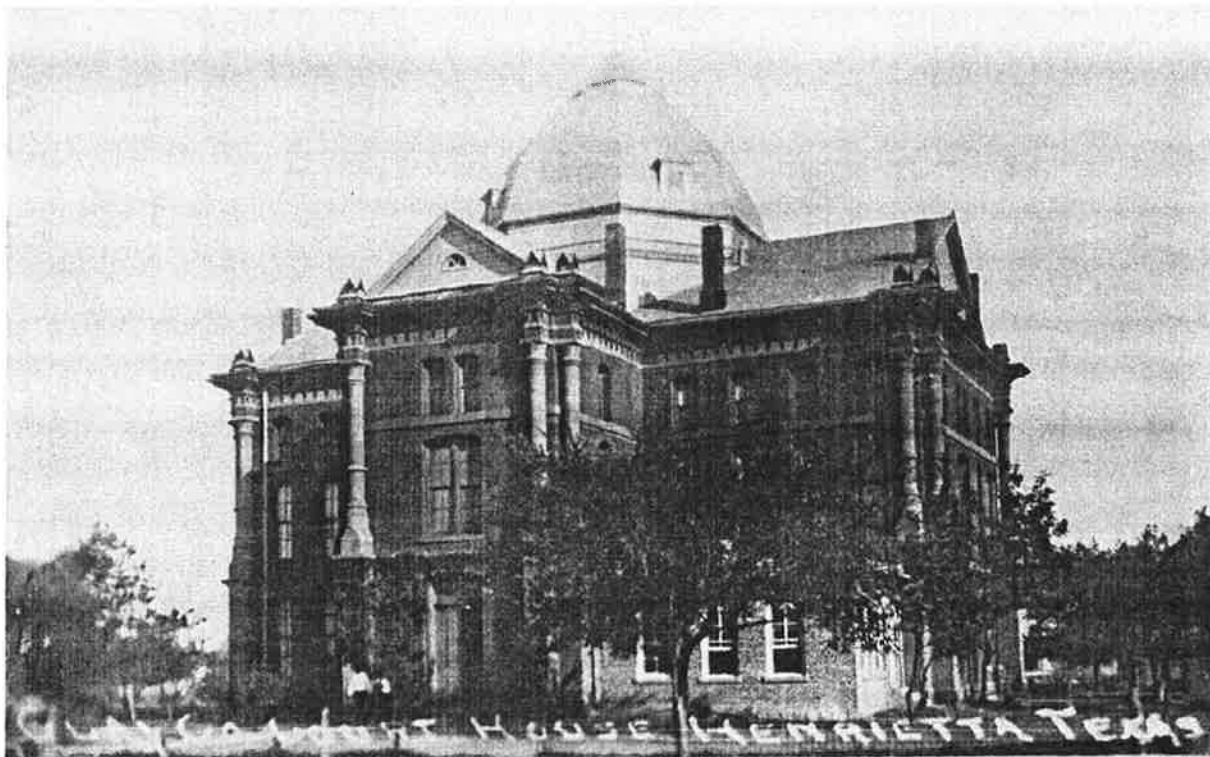
*FIGURES II-12 (ABOVE) AND II-13 (BELOW). The 1920s saw the construction of a one-story annex at the southeast corner of the building. The annex was created to house the sheriff's office and provide much needed expansion space for other office functions. The annex is clearly visible in the photo above. Note that the iron fence has been removed and that new diagonal sidewalks have been added to the site.*

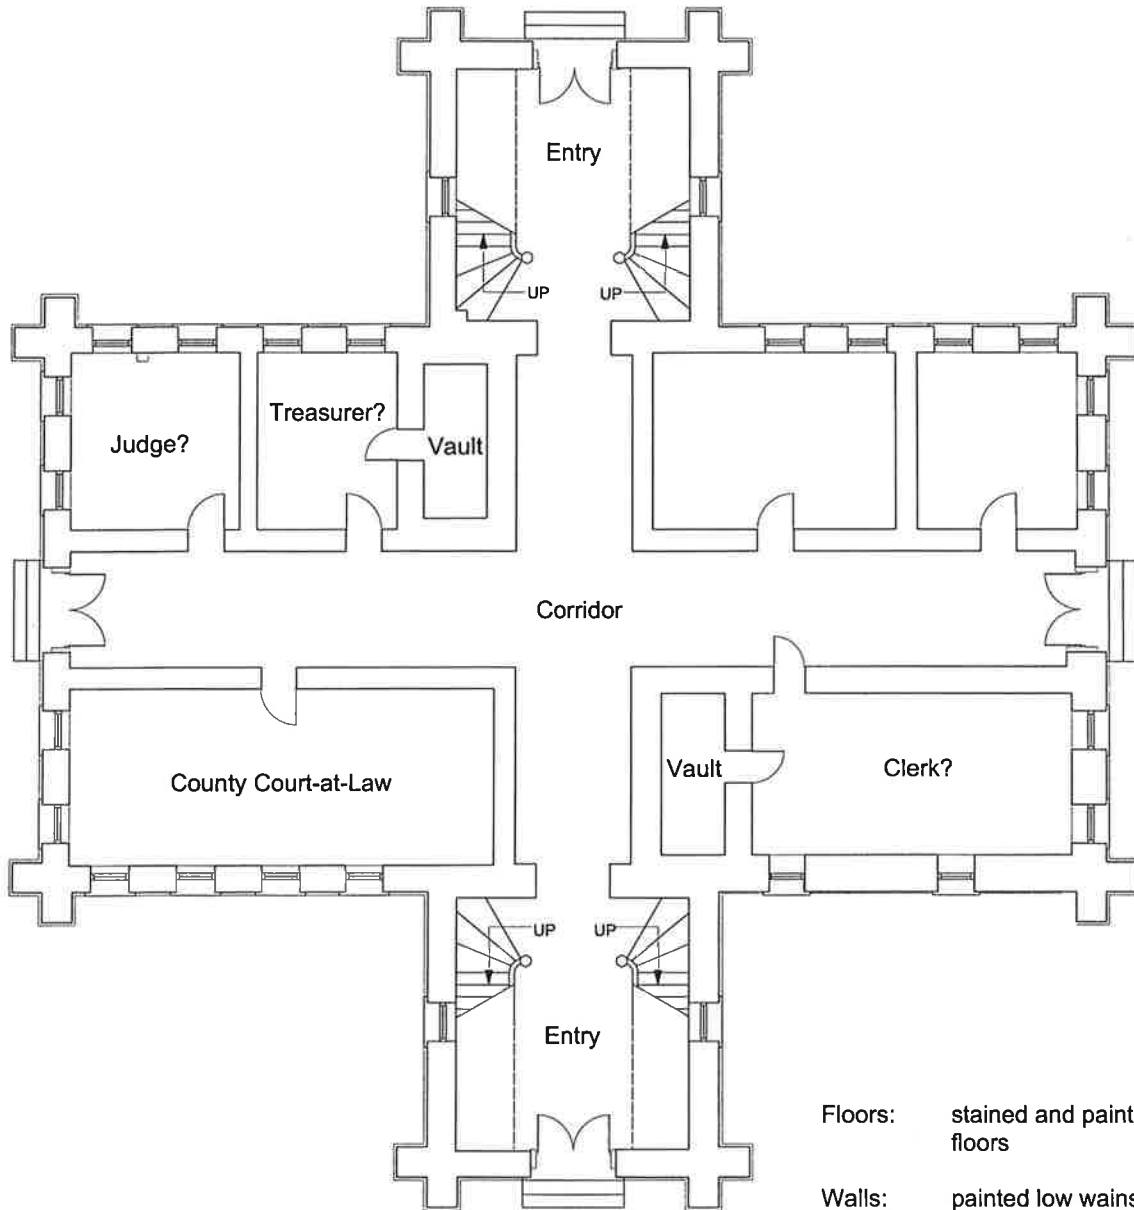
- Floors: stained and painted wood floors
- Walls: painted low wainscot and painted upper plaster
- Ceiling: painted beaded board
- Structure: brick bearing walls and wood joist floors and roof

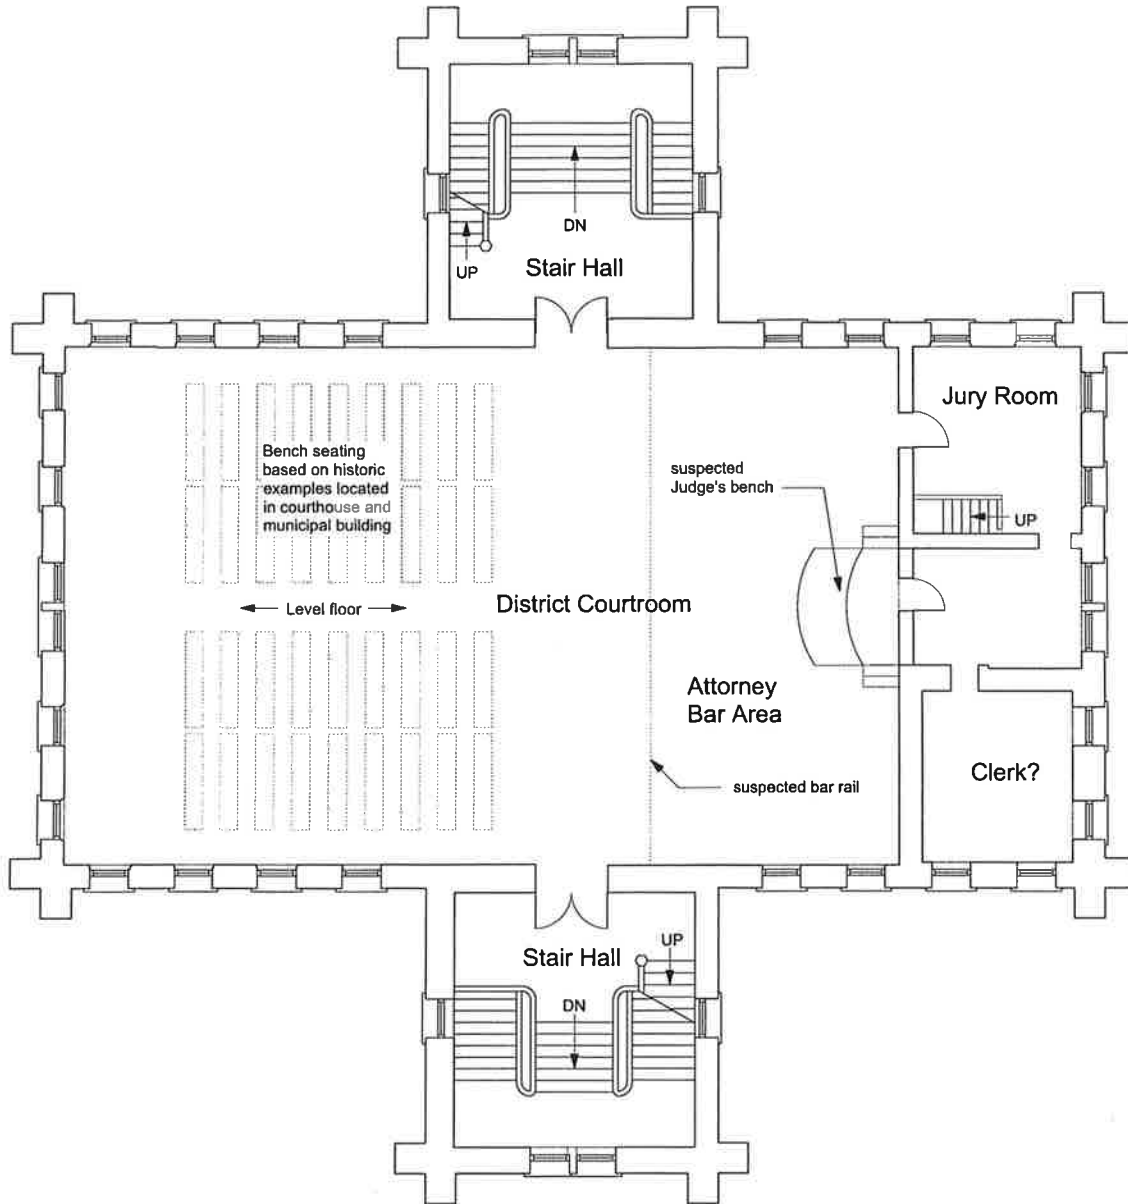
Note: There are no known original plans or early interior photographs. All furnishing assumptions are based on similar conditions of the sister courthouse at Red River County.

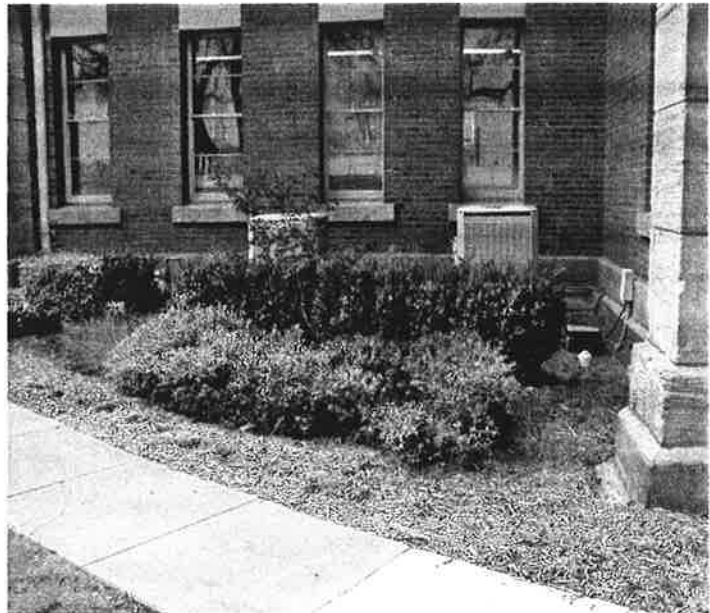
4. Very little of the landscaping appears to match that shown in the historic photographs. The large trees lo-
- FIGURE III-1. Flowerbeds, such as the one shown above are connected to the main sprinkler system, but have no means to drain beyond the sidewalk. This image also shows the exterior HVAC equipment (northeast quadrant).*

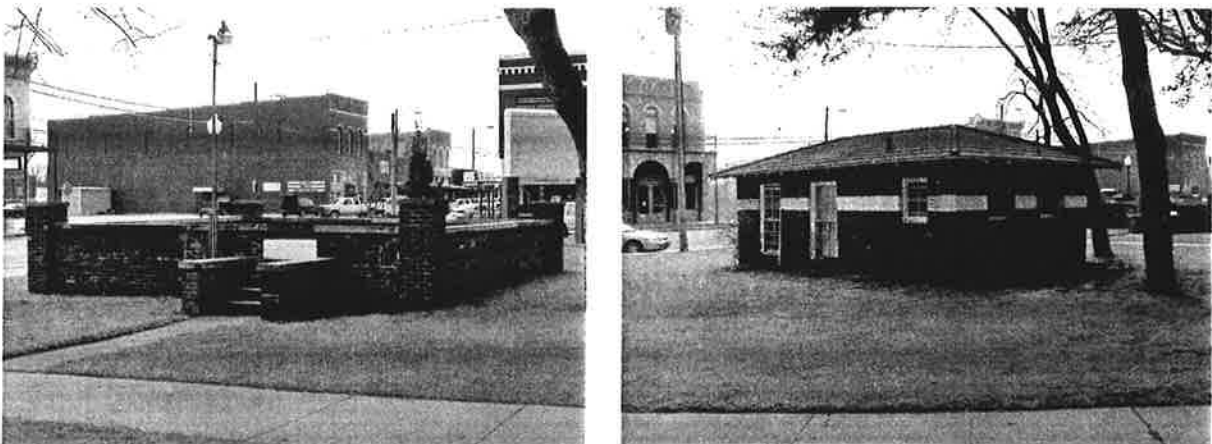
*FIGURE III-2. The bandstand (left) and restroom building (right) were constructed at approximately the same time (1920s) and are in poor condition due to inadequate maintenance. Many citizens support their demolition.*

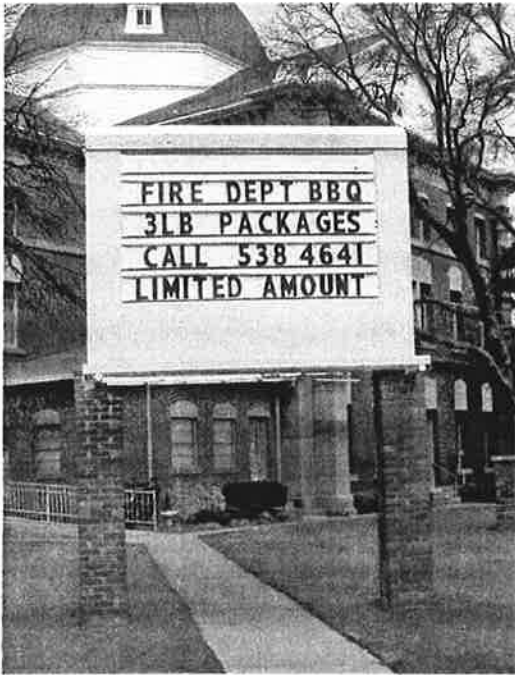
*FIGURE III-3. There are several monuments and one marquee on the courthouse square. The marquee (left) has a negative visual impact on the site. The hereford cattle monument (below) is in excellent condition. The war memorial (below, left) is lighted by floodlights and includes two flagpoles. The centennial monument (below, right) contains a time capsule and has suffered some deterioration since its installation.*

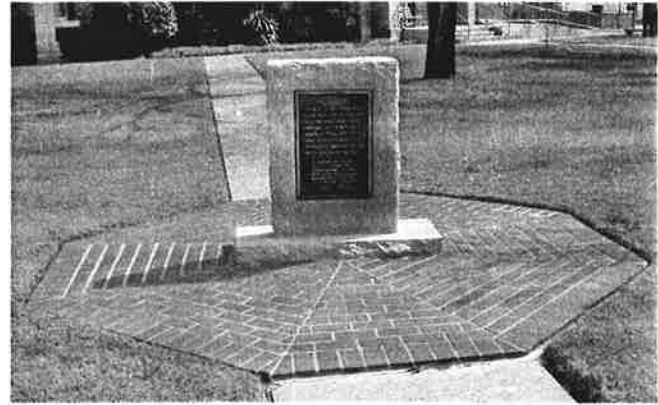
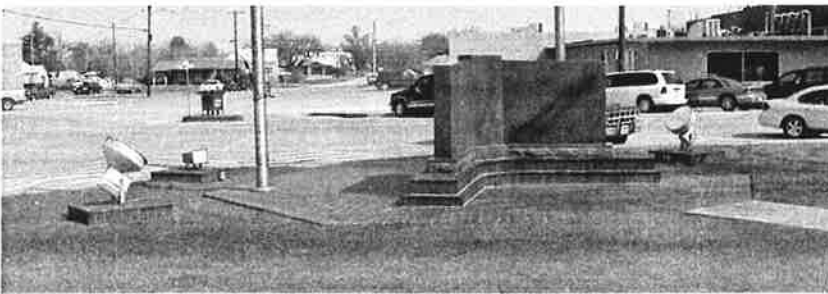
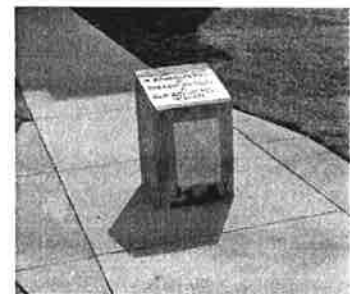
5. The two flagpoles are located next to the war memorial at the northwest corner of the site. The poles are modern aluminum and are in good condition.
6. The granite and bronze hereford cattle monument was installed in 1973 and is in good condition.

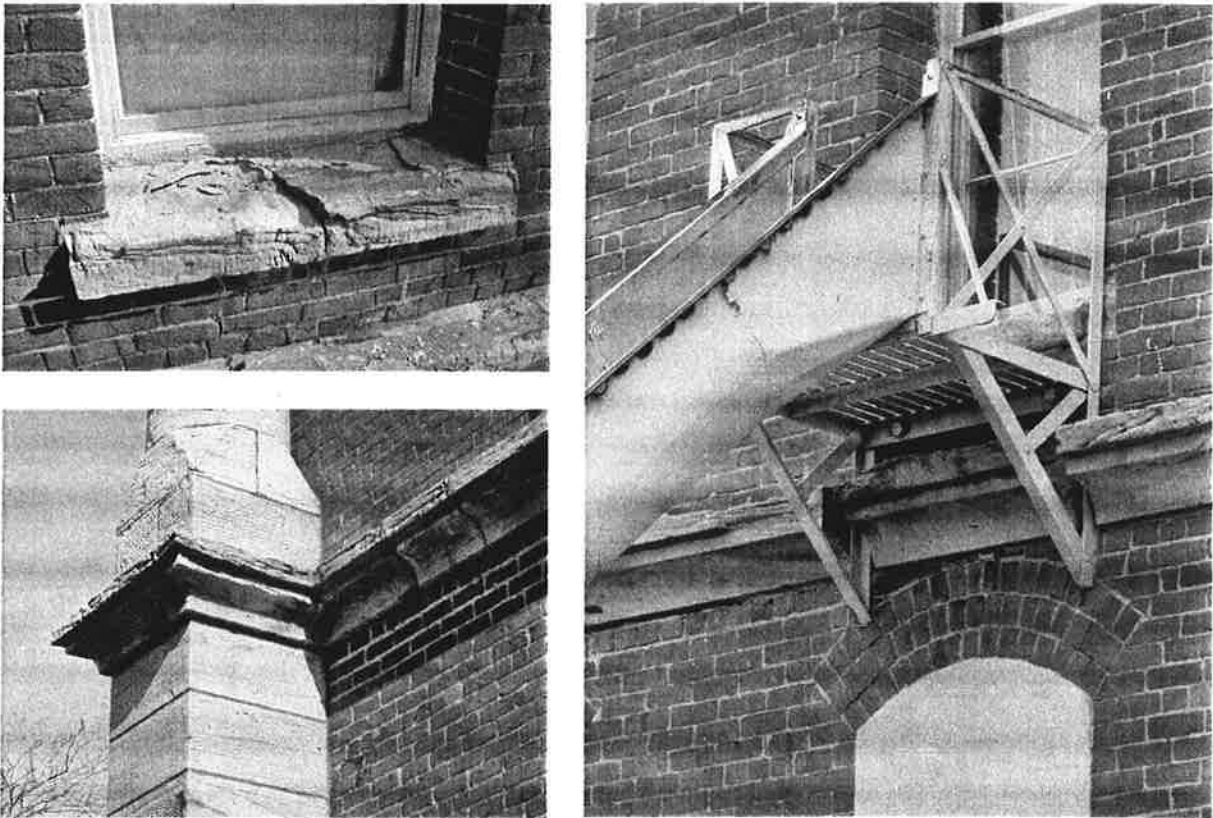
**FIGURE III-4.** The sandstone belt courses (above) and window sills (above, left) are undergoing extreme, rapid deterioration. The stone is delaminating in large pieces. To make matters worse, in most areas where equipment (downspouts, electrical conduit, fire slide, etc.) was mounted to the building (above, right), the stone was cut rather than requiring the equipment to adjust.

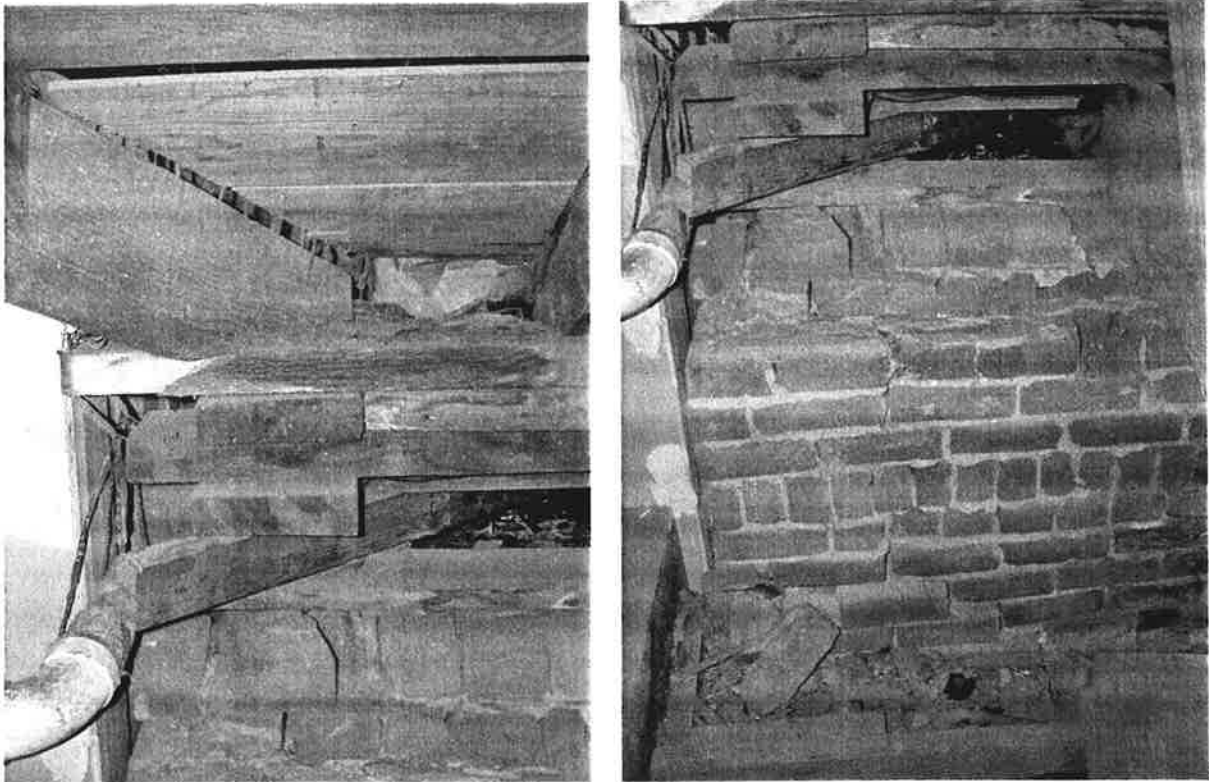
*FIGURE III-5. The weight of the elevator has caused the stair tower to settle differently than the remainder of the building. The pressures involved have allowed the mortar (already weakened by the moisture from a leaking historic internal downspout) to disintegrate. The bricks can be removed from the wall by hand (right) and the roof structure is slowly receding from the roof decking (left). Moisture-related problems are relatively common at the sill plate around the perimeter.*

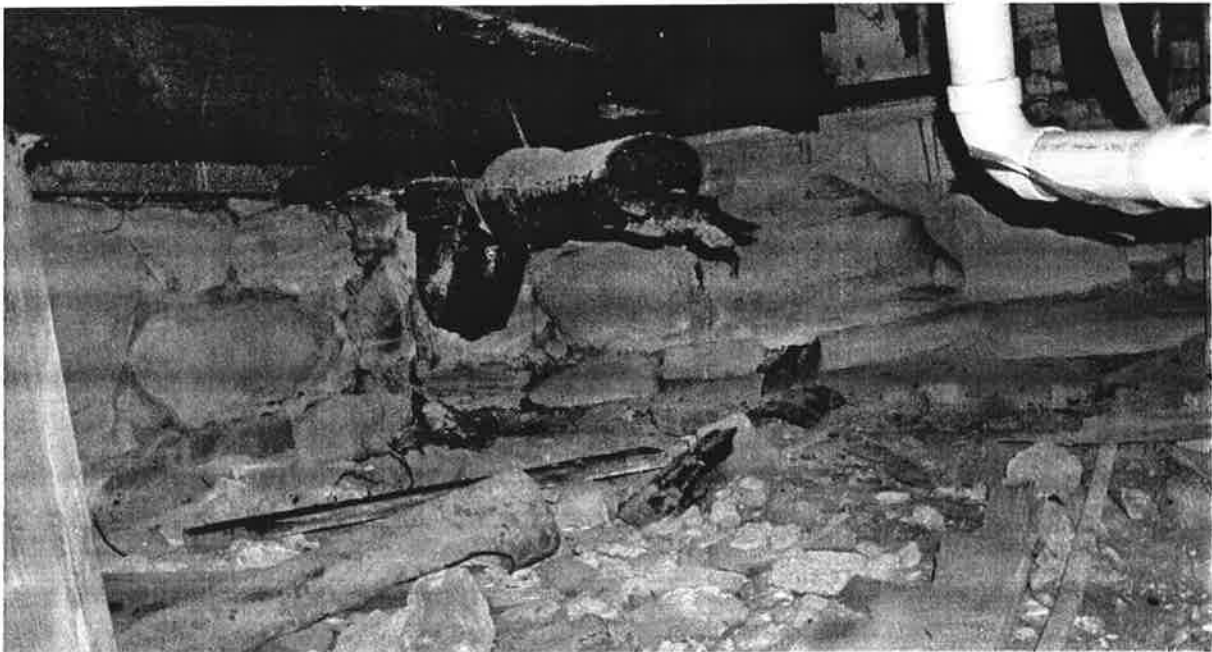
*FIGURE III-6. The foundation sandstone is in relatively good condition. However, evidence of rising damp can be seen in the form of efflorescence on the mortar and in the piles of fine dust (degraded mortar) at the base of the foundation walls. Loss of mortar integrity is a serious problem affecting the future stability of the building.*

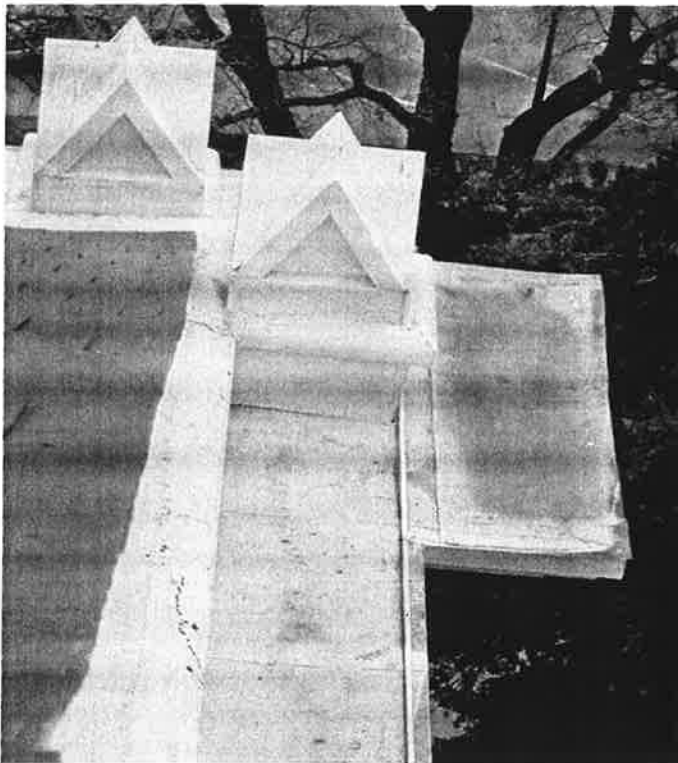
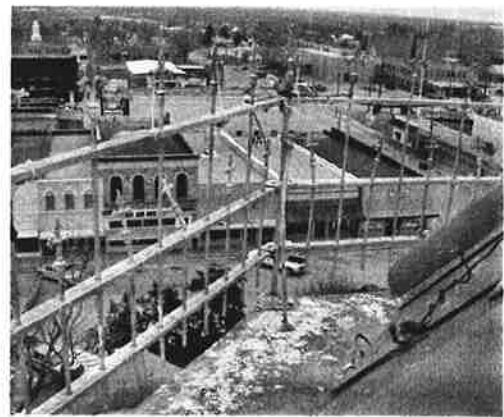
*FIGURE III-7. The cresting shown above serves as the rail for the widow's walk at the top of the dome. The cresting was designed to match the original iron fence that was still existing at the time the cresting was installed.*

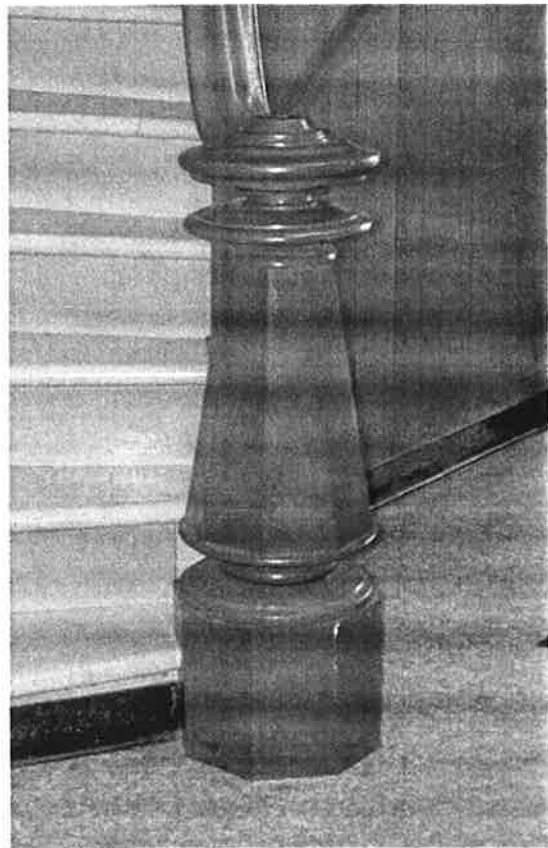
*FIGURE III-9. While most of the interior woodwork appears to have been painted originally, the newel posts seems to have been stained. A century's worth of hands has worn the decorative button atop the south newel post almost completely away.*

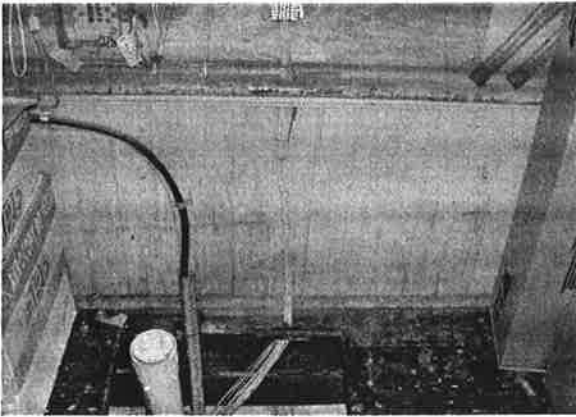
**FIGURE III-10.** Original wainscot is visible only in the closets tucked under the north and south stairs. Scrapings done in these areas surprisingly showed no indications of the dark stain common at the time.

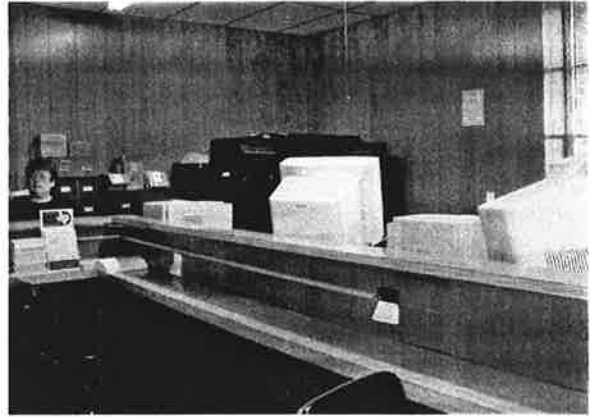
**FIGURE III-11.** The image above illustrates the typical office condition. Wood paneling covers the walls from the base to the acoustic tile ceiling. A non-original counter can be seen in the foreground.

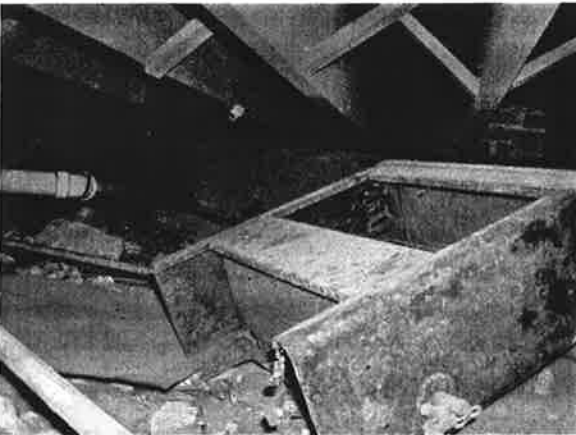
**FIGURE III-12.** The crawlspace is a jumbled array of active and abandoned utility equipment, original construction debris, and everyday trash. The 2x14 joists and cross bracing appear to be in good shape.

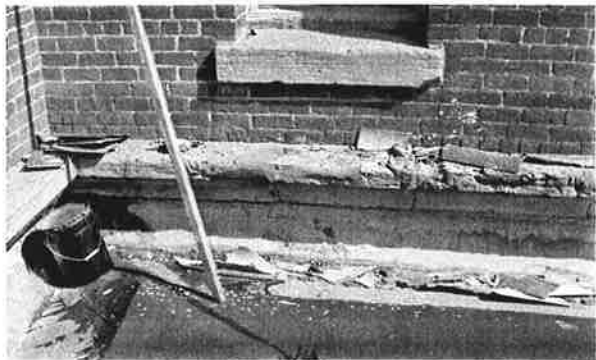
*FIGURE III-17. While the annex has red tile roofing on the south and east, the non-visible north and west sides are rolled roofing only. Past repair efforts have left behind a significant amount of debris, most of which can be found blocking the flow of the gutter.*

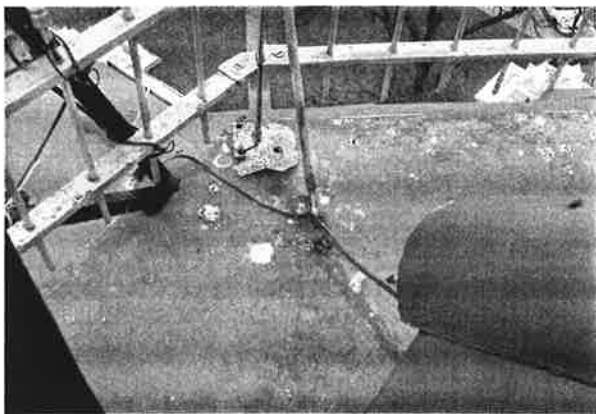
*FIGURE III-18. The flat roofing at the top of the dome seems to be in good condition. None of the seams were found to be cracked. However, some minor deterioration was noted at the creasting attachments.*

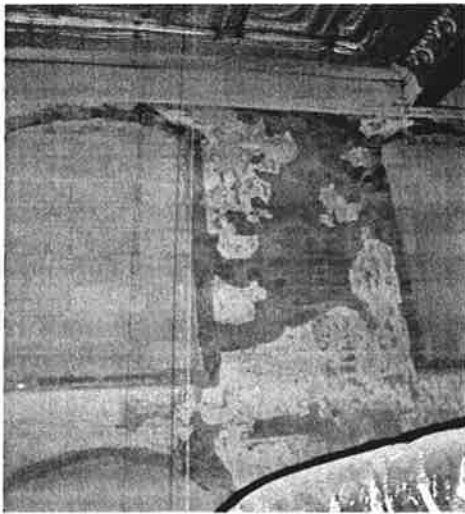
**FIGURE III-22 (FAR LEFT).** All of the third floor windows and the arched portions of all of the other windows are blocked with CMU and plaster as seen here above the ceiling of the current jury room. The extreme degradation of the plaster on the walls is very alarming. However, no cause beyond general moisture penetration was discovered. The damage is possibly due to a leak that has since been repaired.

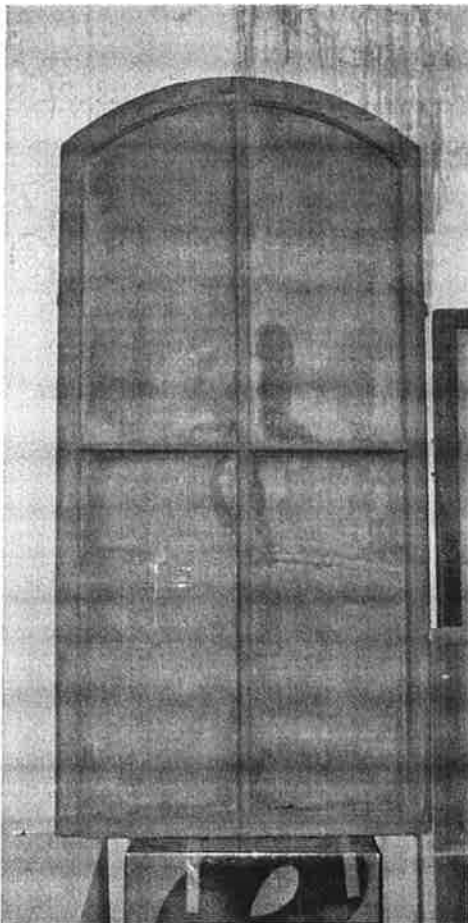
**FIGURE III-24.** The original window sash pictured above was found in the third floor space above the north stair. It is the upper sash of one of the 4-over-4 windows. The exterior face appears to have been painted black originally. The interior side of the window appears to have also been painted.

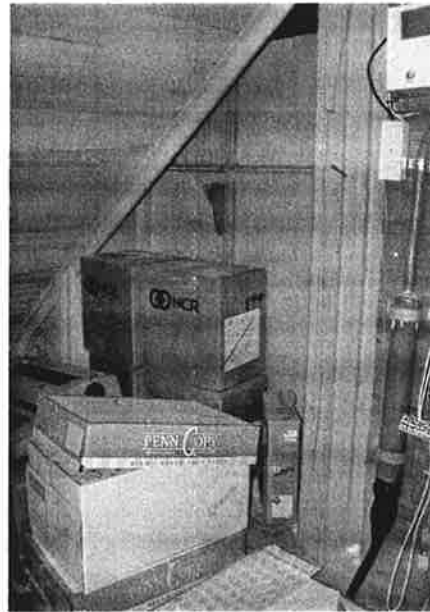
**FIGURE III-23 (LEFT).** There is only one original window left in its original location in the courthouse. This window was sandwiched between the annex and the courthouse in the 1920s. When the replacement windows were installed in the 1960s this window was overlooked. Fortunately, renovators left not only the window but all of its original trim in place.

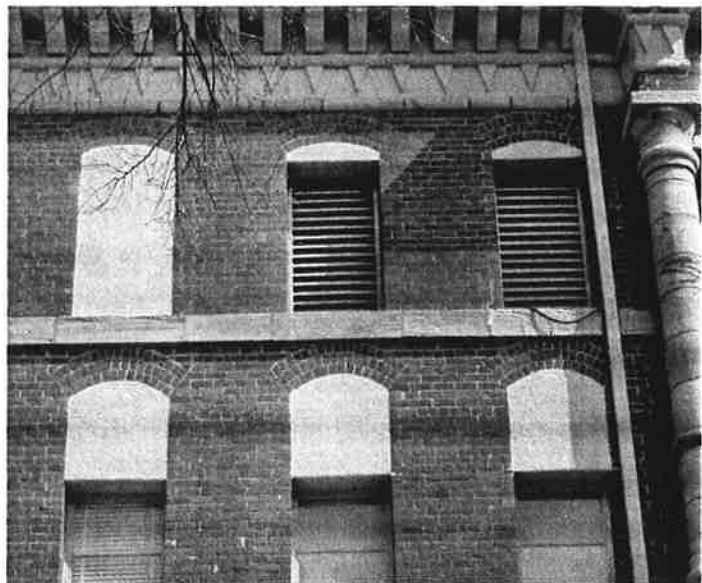
**FIGURE III-25.** This image shows all of the various window treatments currently existing. Most third floor windows are fully blocked. Only a very few have been converted to louvers. The remainder of the windows have been only partially blocked. The blockage corresponds to the location of the ceiling inside the building. Also, by filling the arch, the replacement windows could be cheaper, standard units.

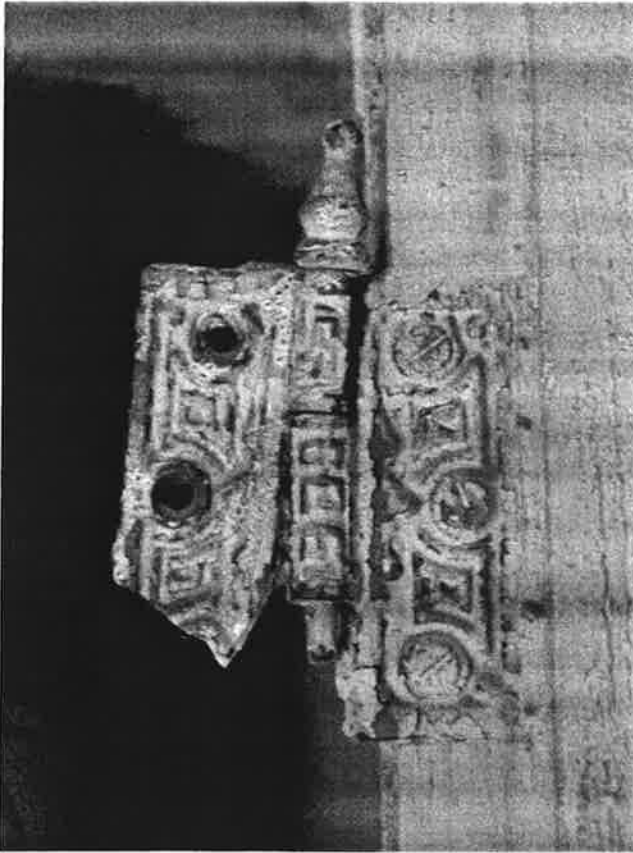
**FIGURE III-26 (LEFT).** There are only a very few examples of the original hardware remaining in the building. This hinge, located in the third floor spaces above the current District Clerk's office, was apparently damaged when the original door was removed. The small size of the hinge suggests that the doors were relatively thin and light. The tan color is painted over a light gray. However, the gray could be primer.

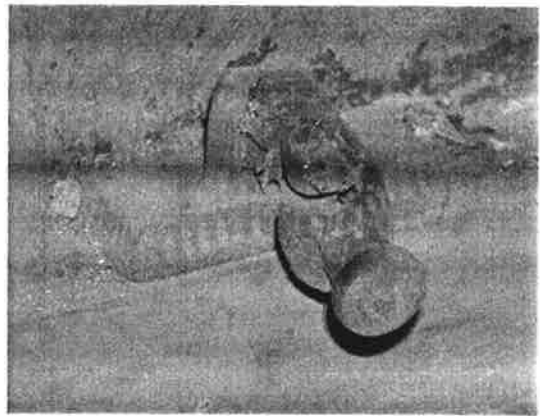
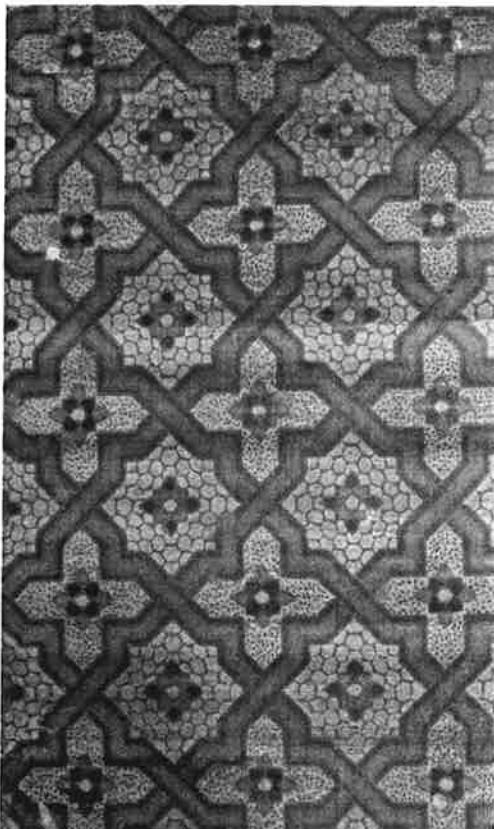
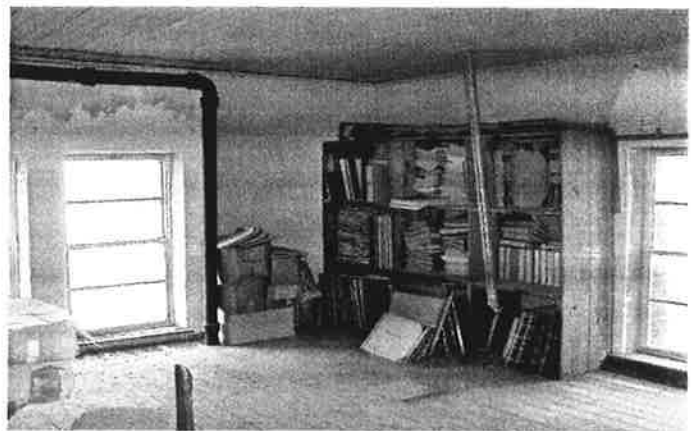
**FIGURE III-28 (ABOVE).** The third floor space above the north stair is essentially in its original condition. The 4" pine plank floor is exposed and unfinished. The original internal downspouts are visible through holes in the ceiling at the southeast and southwest corners of the room.

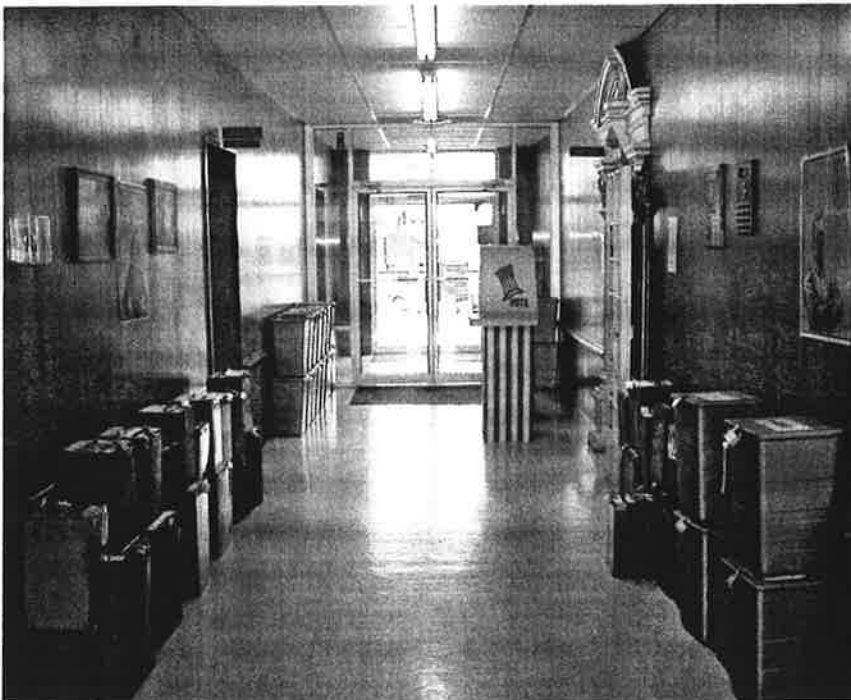
*FIGURE III-30. This image illustrates the typical condition for the public circulation spaces. The floors are covered in sheet vinyl. The walls are wood paneling. The ceiling is non-textured, exposed grid, acoustical tile. Typical lighting is via exposed tube strip fluorescents. In general, interior finishes consist of simple, economical materials. Each entrance is protected by an airlock-type double door vestibule. The aluminum storefronts, combined with the lowered ceilings, serve to decrease the apparent size of the courthouse as it is perceived by visitors.*

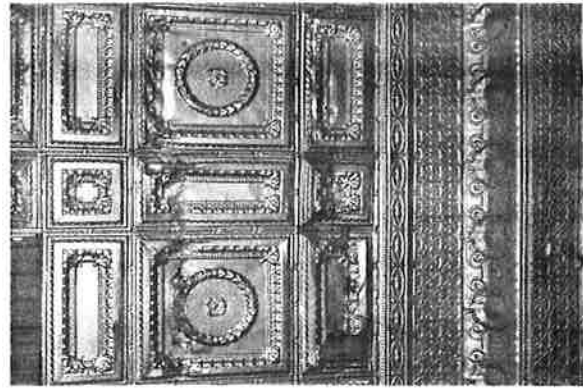
**FIGURE III-31.** In 1911, the District Courtroom was outfitted with a decorative pressed metal ceiling. While the ceiling is existing, it has apparently begun to rust from the backside. Ragged holes have formed in metal that appears to be in pristine condition, suggesting water infiltration causing rust from the top side of the metal panels.

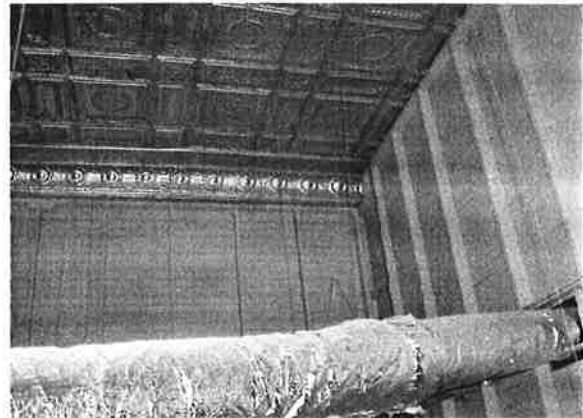
**FIGURE III-32.** At some point, possibly as late as the 1940s, the courtroom was remodeled and the western twenty feet walled off for use as office space. The wall was built with studs and planks. The rough structure is fully painted which suggests that it was intended to be exposed on the office side.

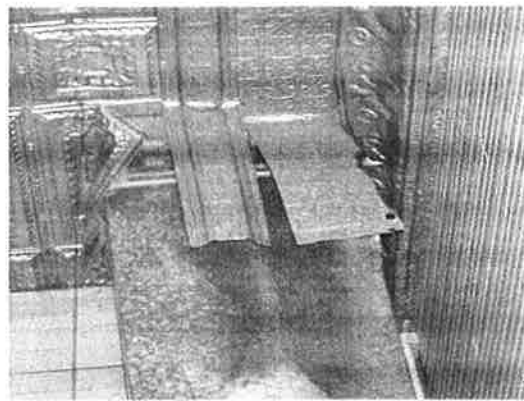
**FIGURE III-37.** HVAC penetrations have done significant damage to the historic metal ceiling in the District Courtroom.

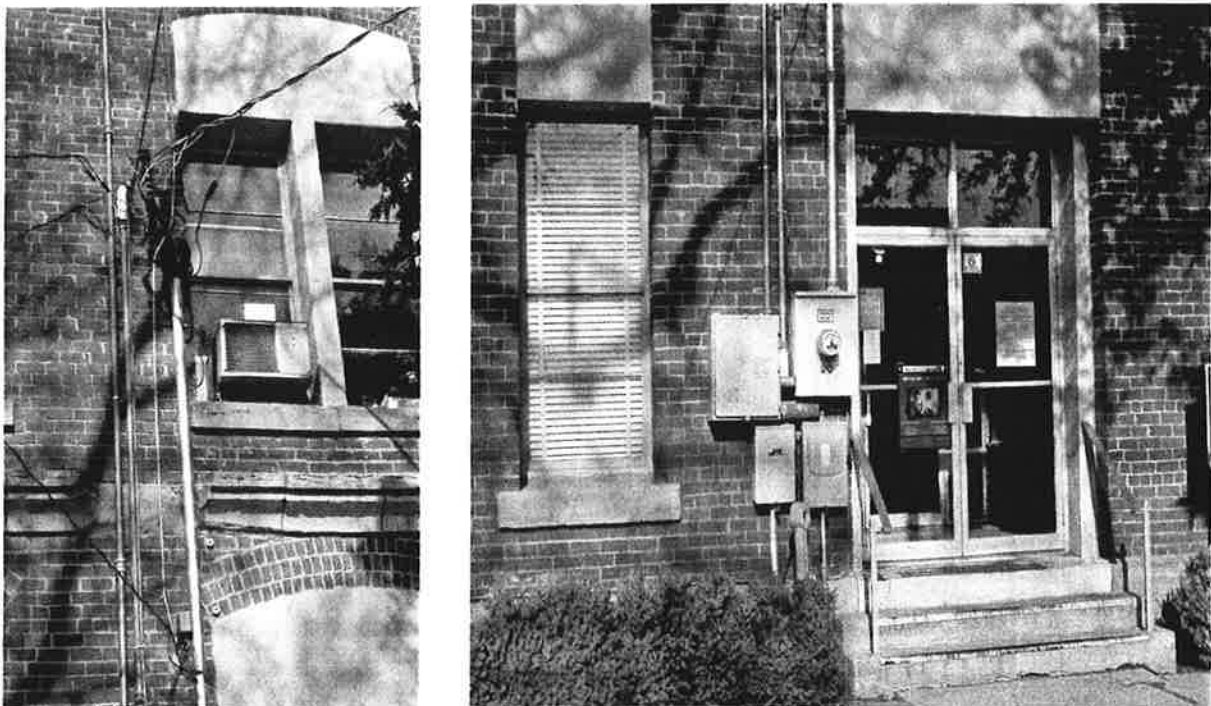
*FIGURE III-38. As part of installing the weatherhead, a portion of the stone belt course was removed (left). The resultant installation has an extremely negative impact on the visual aesthetic of the east facade of the courthouse, as visitors are forced to enter the building in close proximity to the equipment (right).*

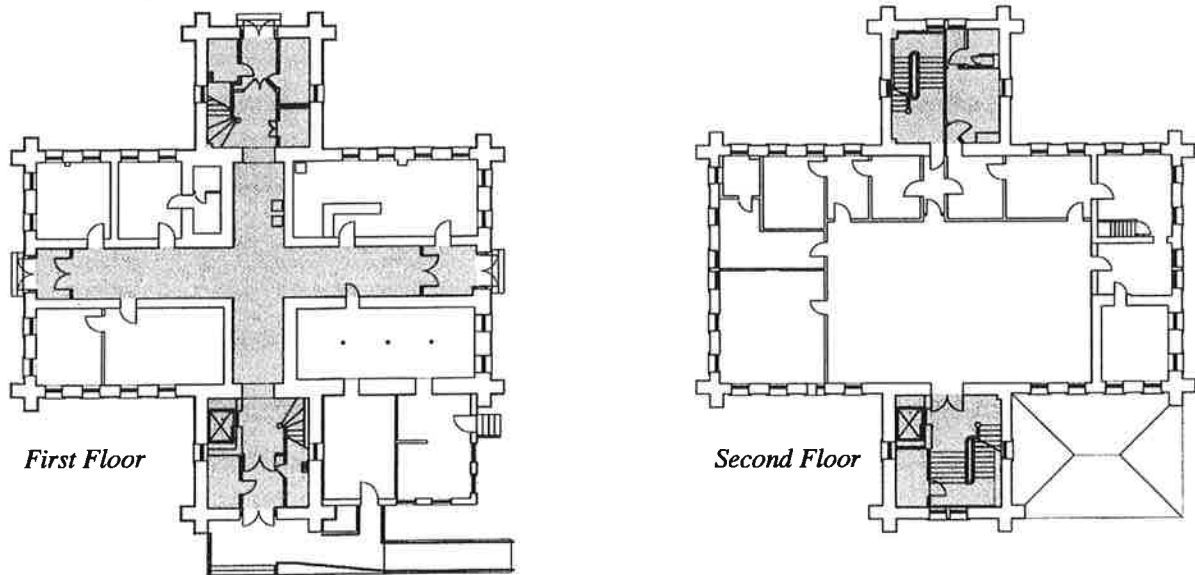
### CORRIDORS AND STAIRS
