## TITLE PAGES AND CONTENT

# **CLAY COUNTY COURTHOUSE OF 1884**

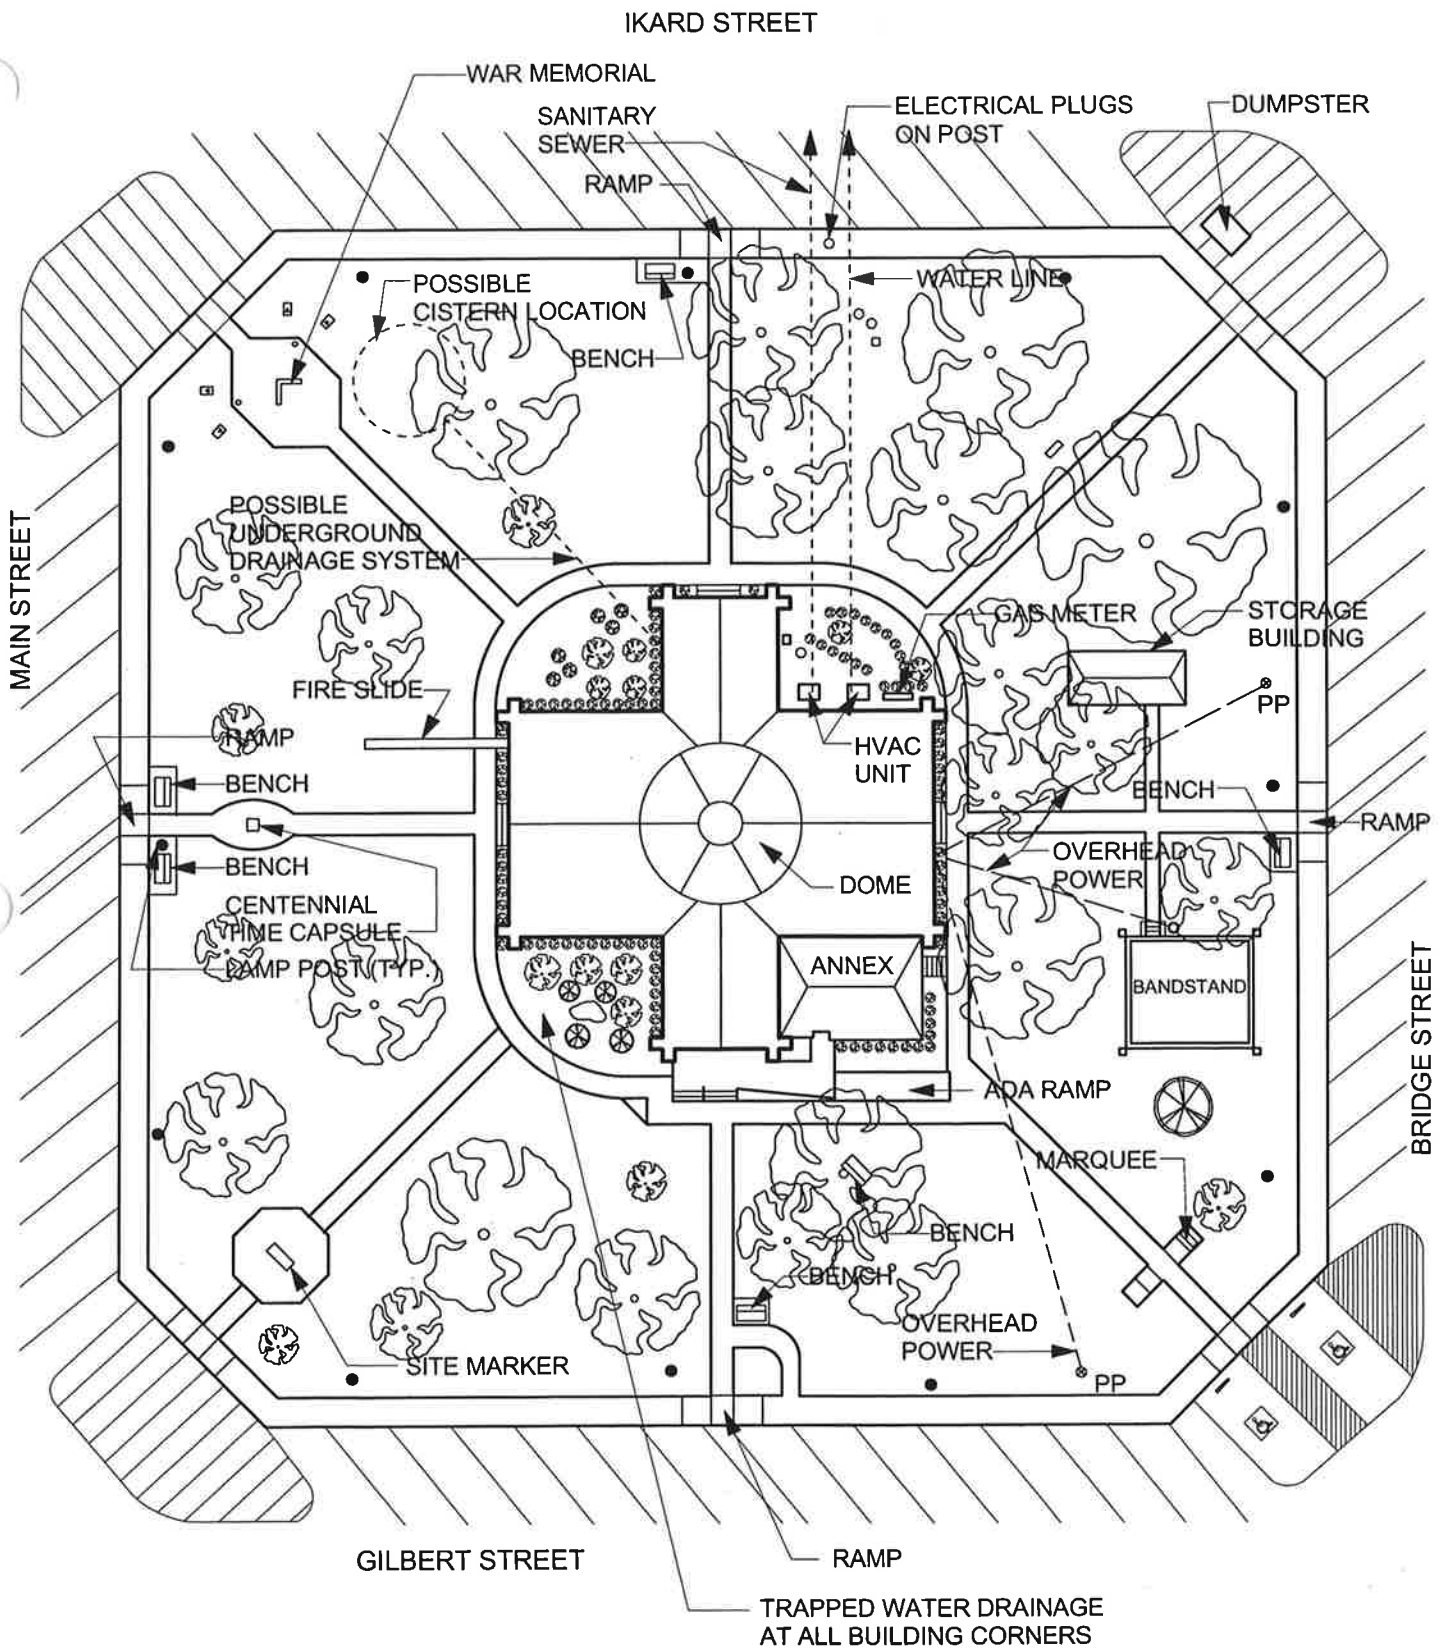
**EXISTING SITE PLAN**

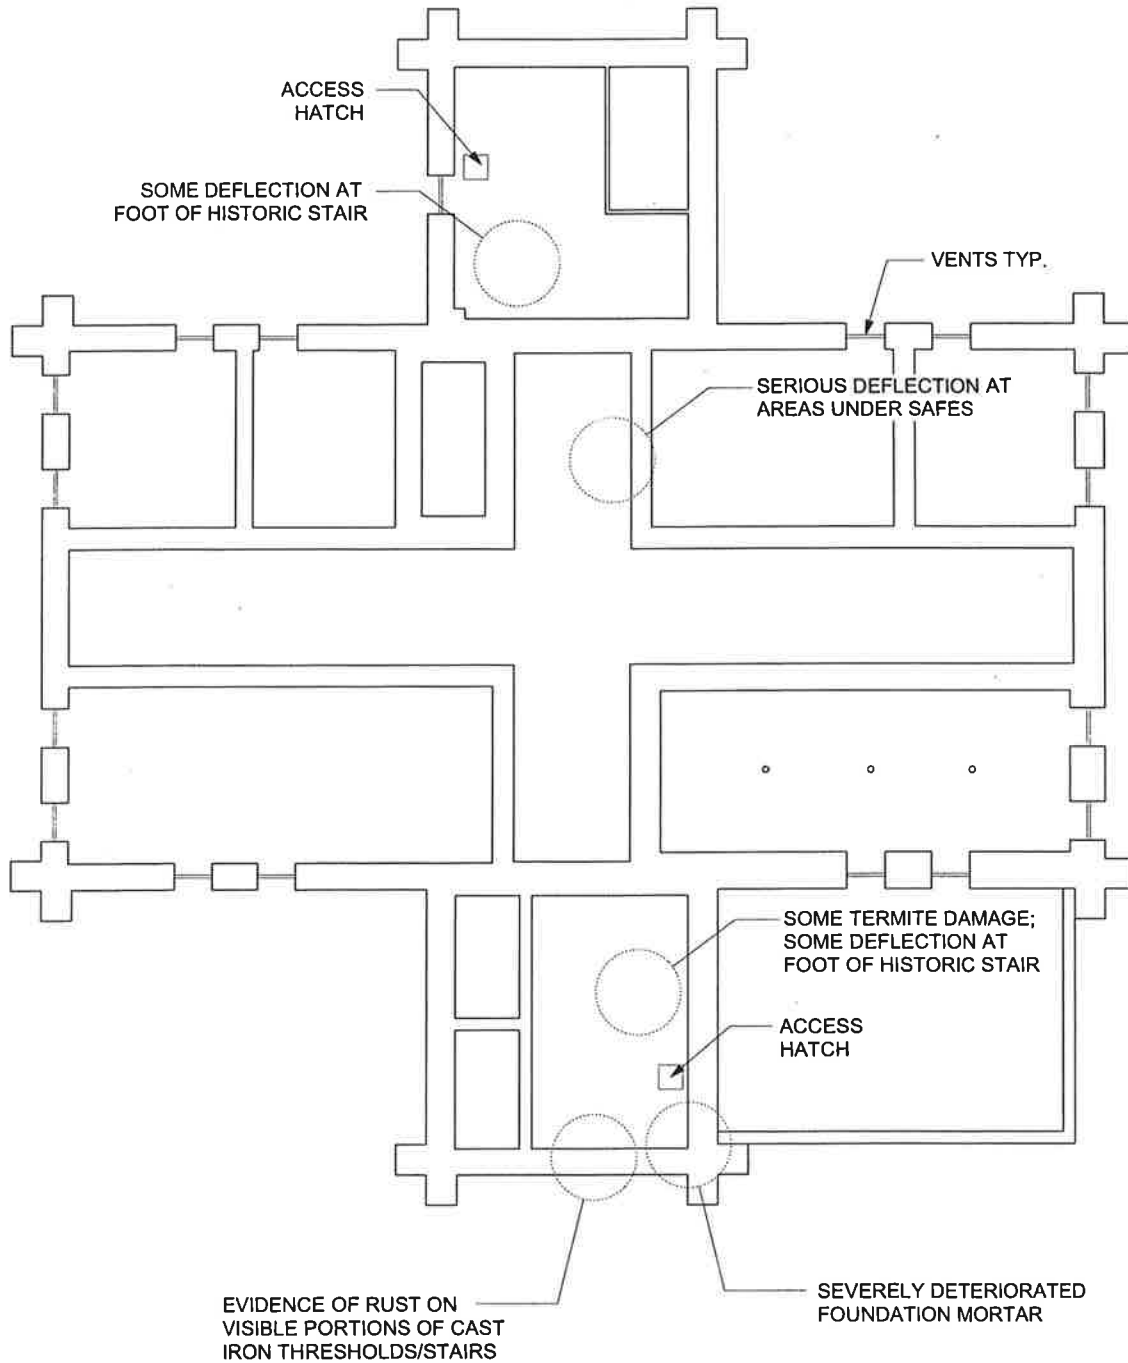
**EXISTING FOUNDATION PLAN**

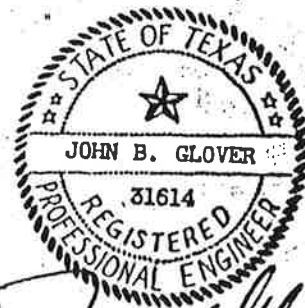
Roof was checked out on September 14 and found to be in good shape except for the missing ridge cap tile as you step out the hatch door on North side. Metal gutters are fairly clean, but it needs to be noted that they must be cleaned at least once a year.

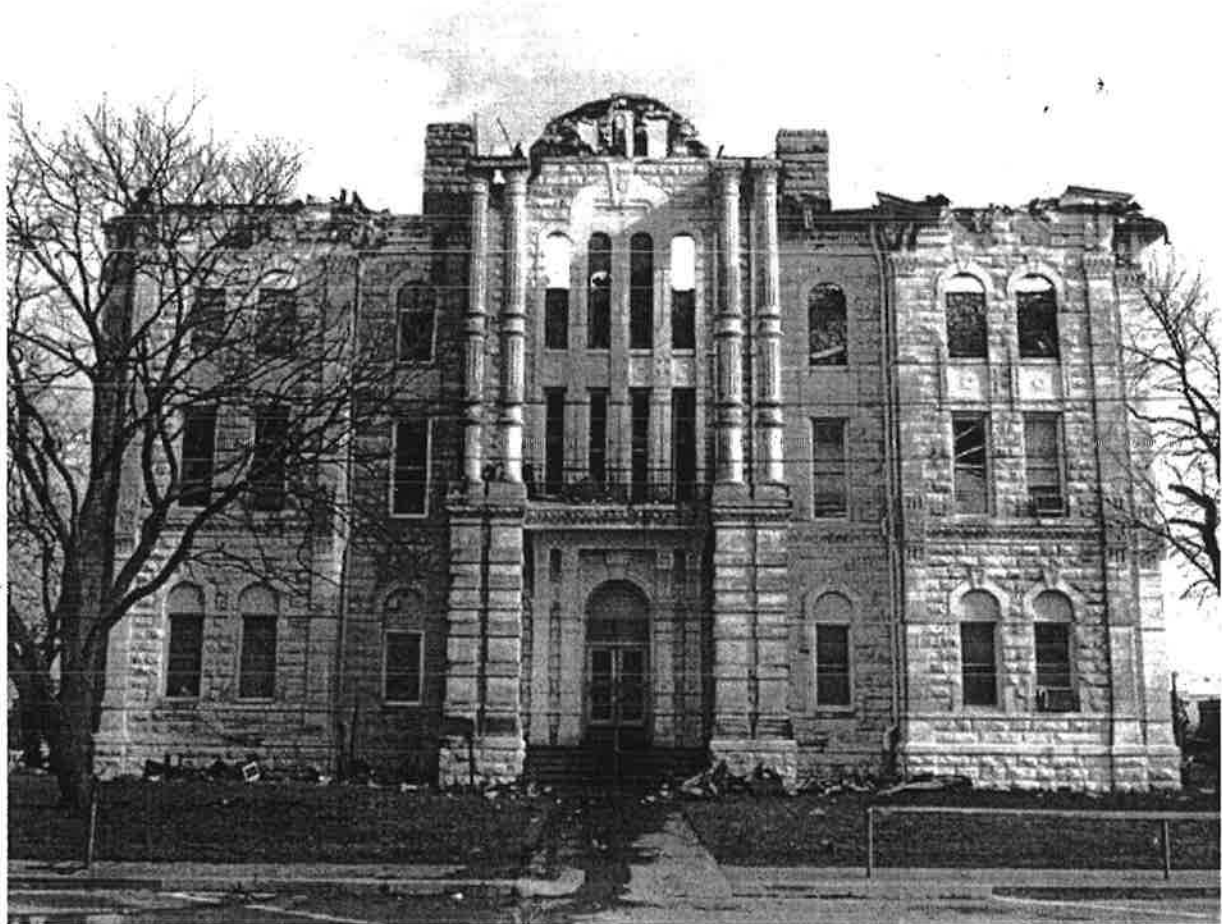
*Hill County Courthouse after New Year's Day fire, 1993. (photo from THC files)*

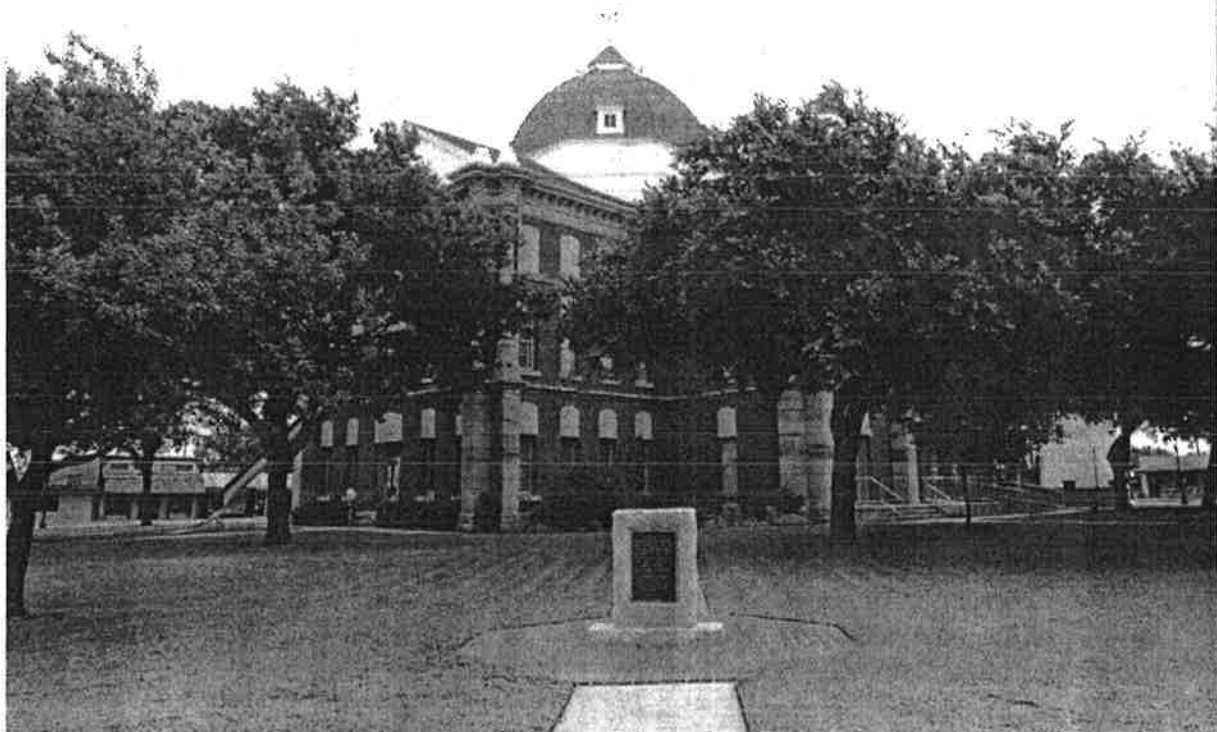
*The courthouse square is in good condition and provides a pleasant atmosphere. (Photo from THC files)*

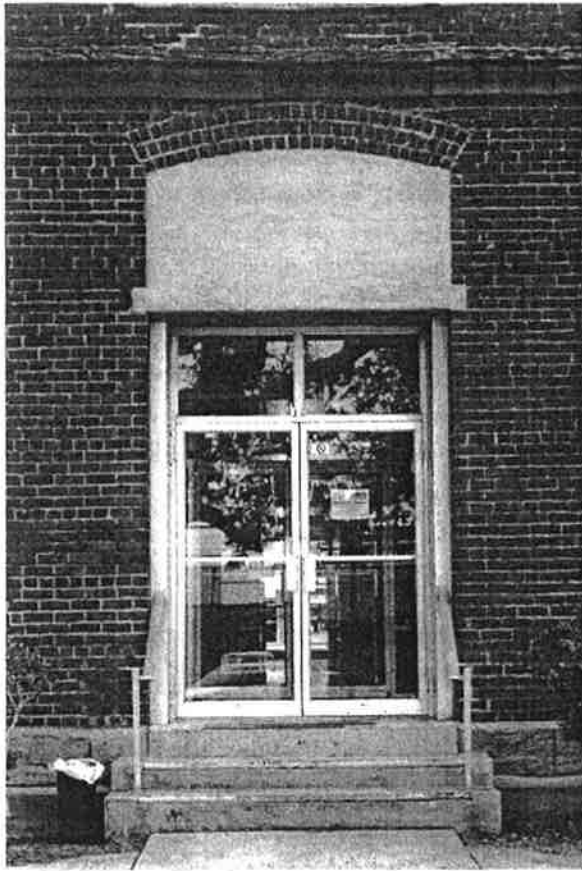
*Aluminum replacement doors detract significantly from the appearance of the building. (Photo fro THC files)*

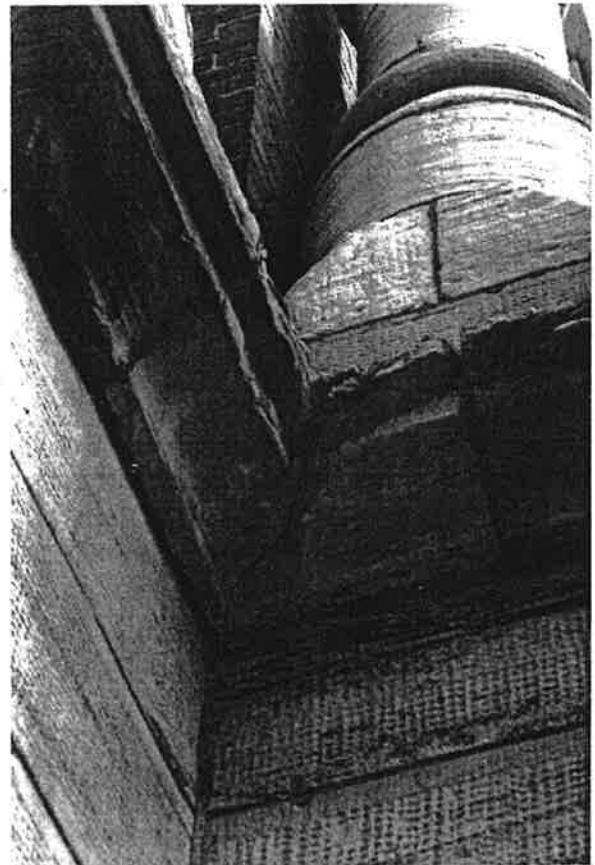
*Stone erosion and other forms of deterioration are evident. Previous abrasive cleaning has contributed to the problems. (Photo from THC files)*

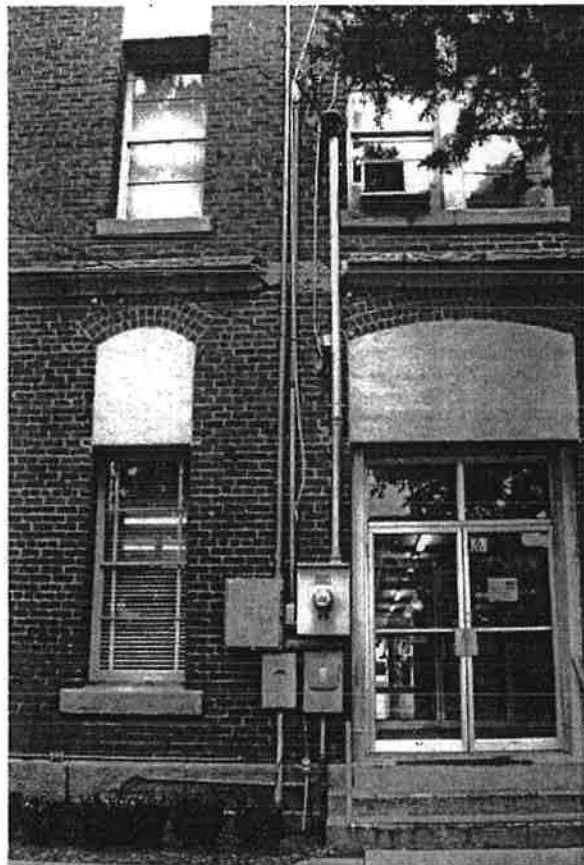
*A myriad of detrimental changes exist on the building exterior, including aluminum doors and windows that do not fit original openings, surface mounted conduits, and damaging alterations to the masonry.  
(Photo from THC files)*

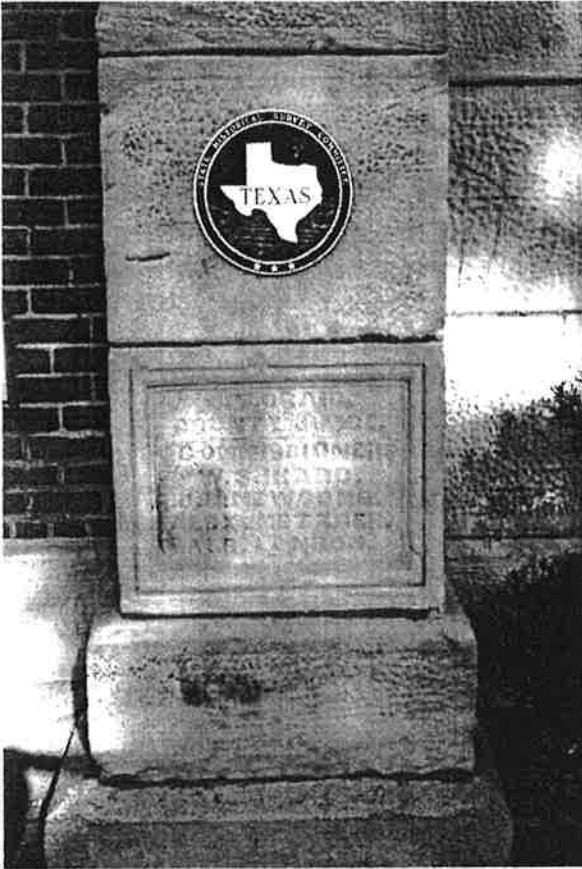
Objects which must be fastened to the building should be applied with non-corrosive fasteners.

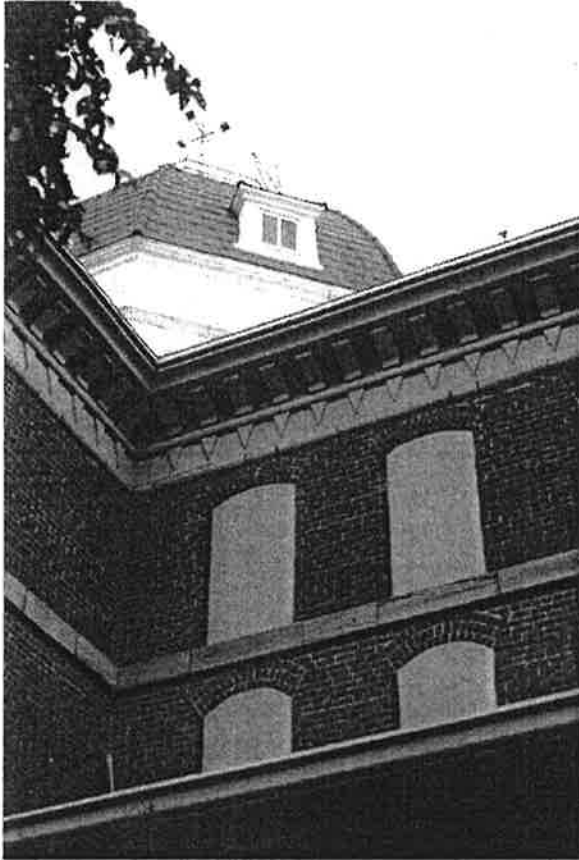
*Windows that have been completely enclosed should be restored. (Photo from THC files)*

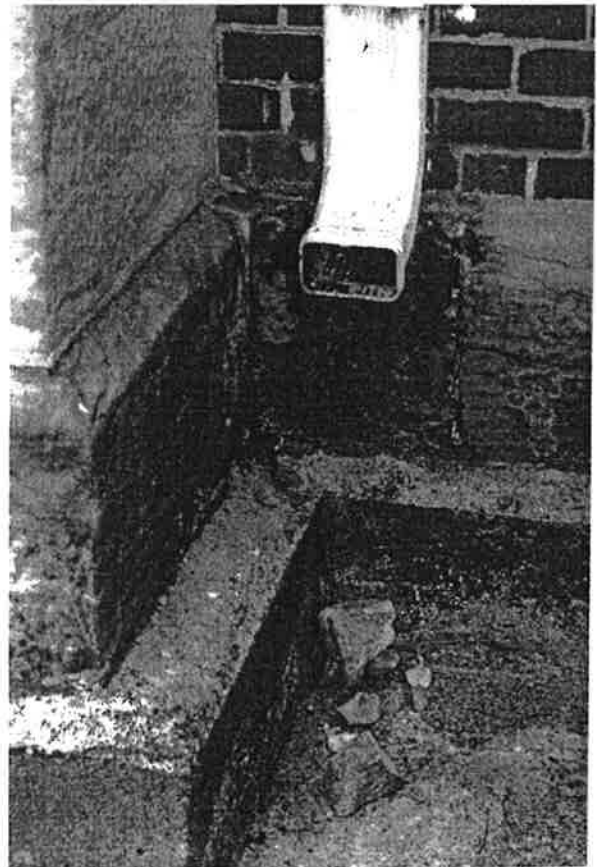
*Downspouts should be configured to direct water away the building. (Photo from THC files)*

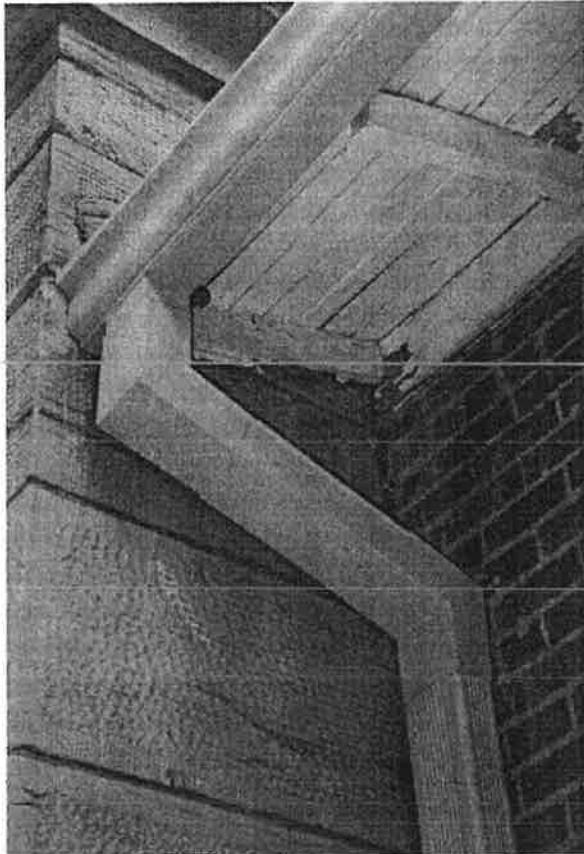
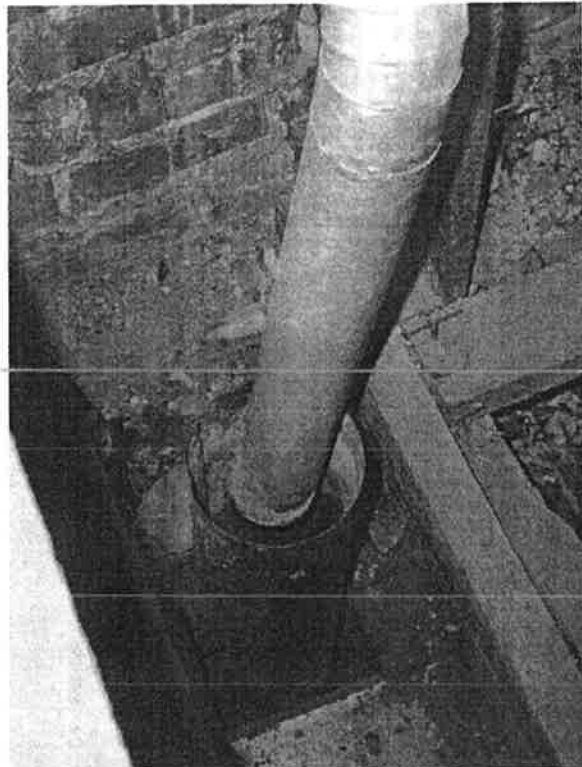
*Roof and flashing deterioration have damaged the soffit of the addition (left). Internal downspouts are still connected and can be seen in the attic (above). The termination of these downspouts at ground level should be investigated. (Photos from THC files)*

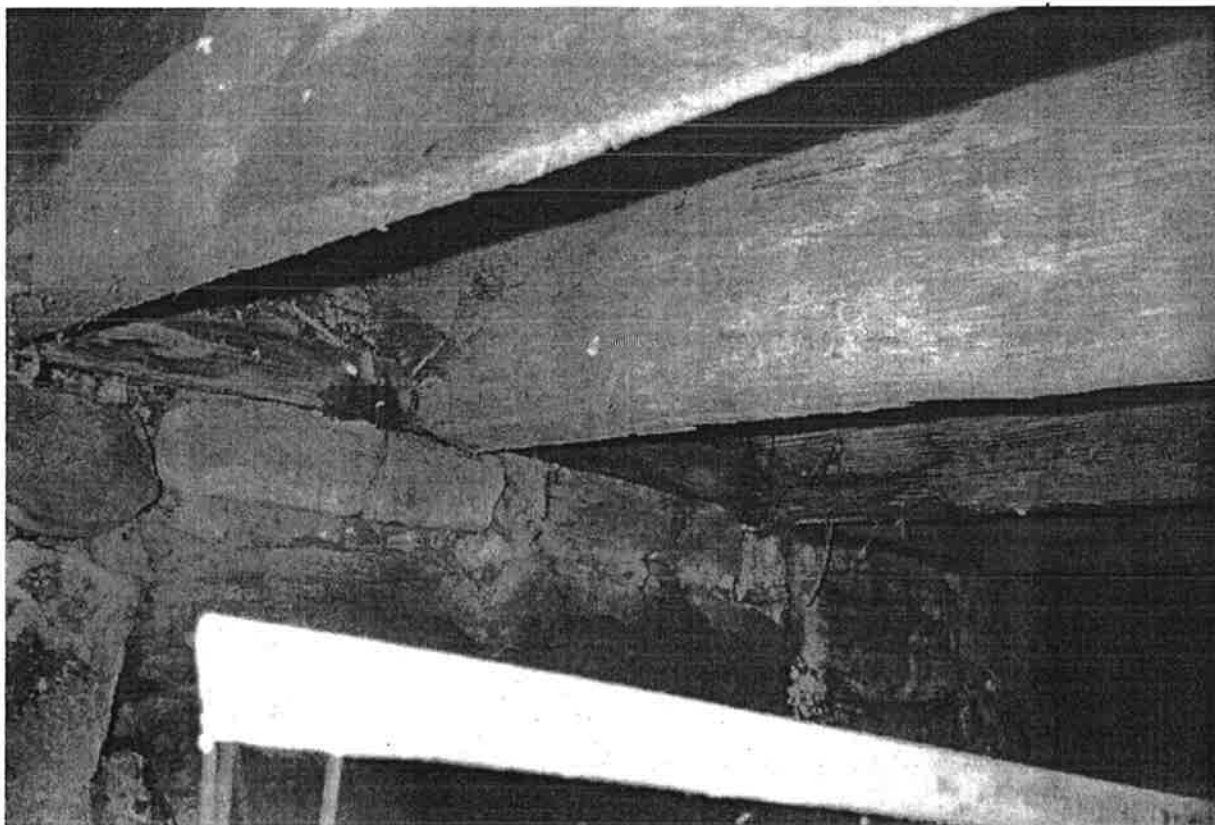
*Moisture problems are evident in the crawlspace. The condition of wood structures should be further investigated to determine the extent of the damage. (Photo from THC files)*

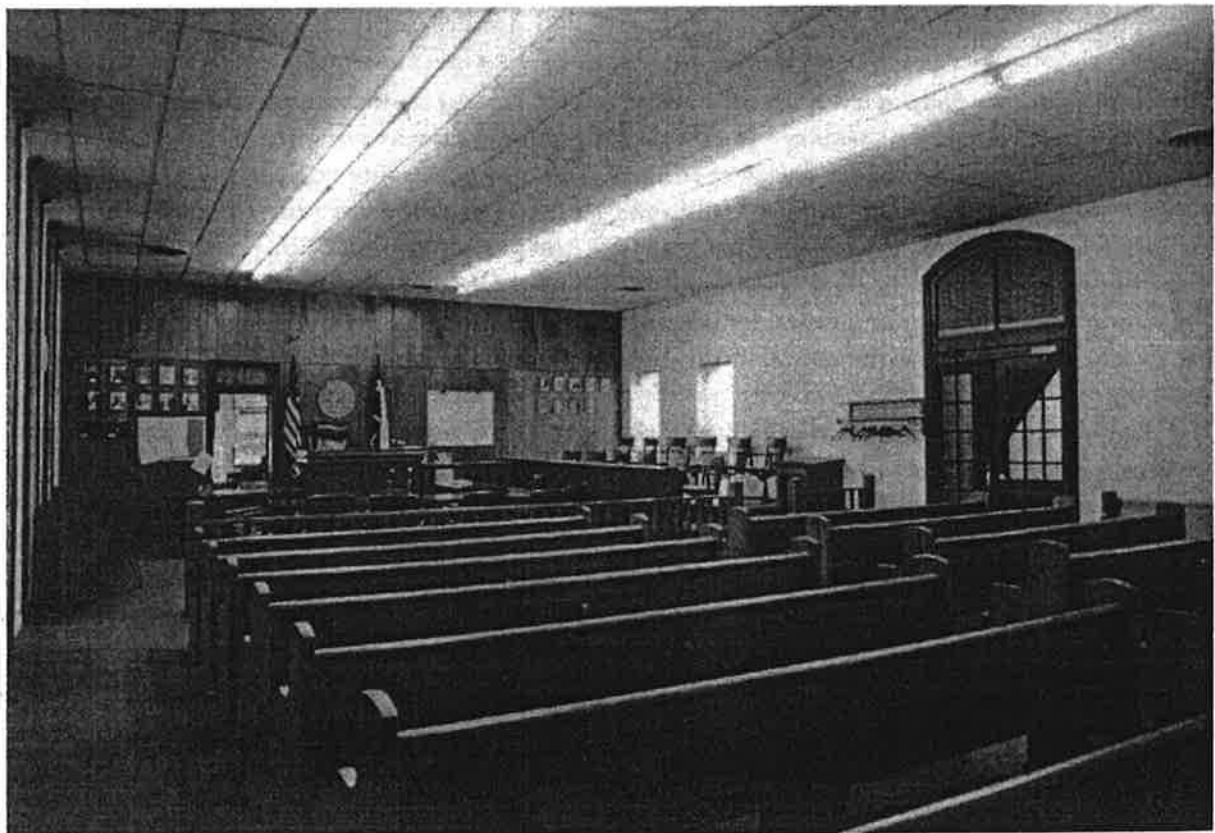
*Dramatic changes to the District Courtroom should be reversed and this dramatic public space restored to its original grandeur. (Photo from THC files)*

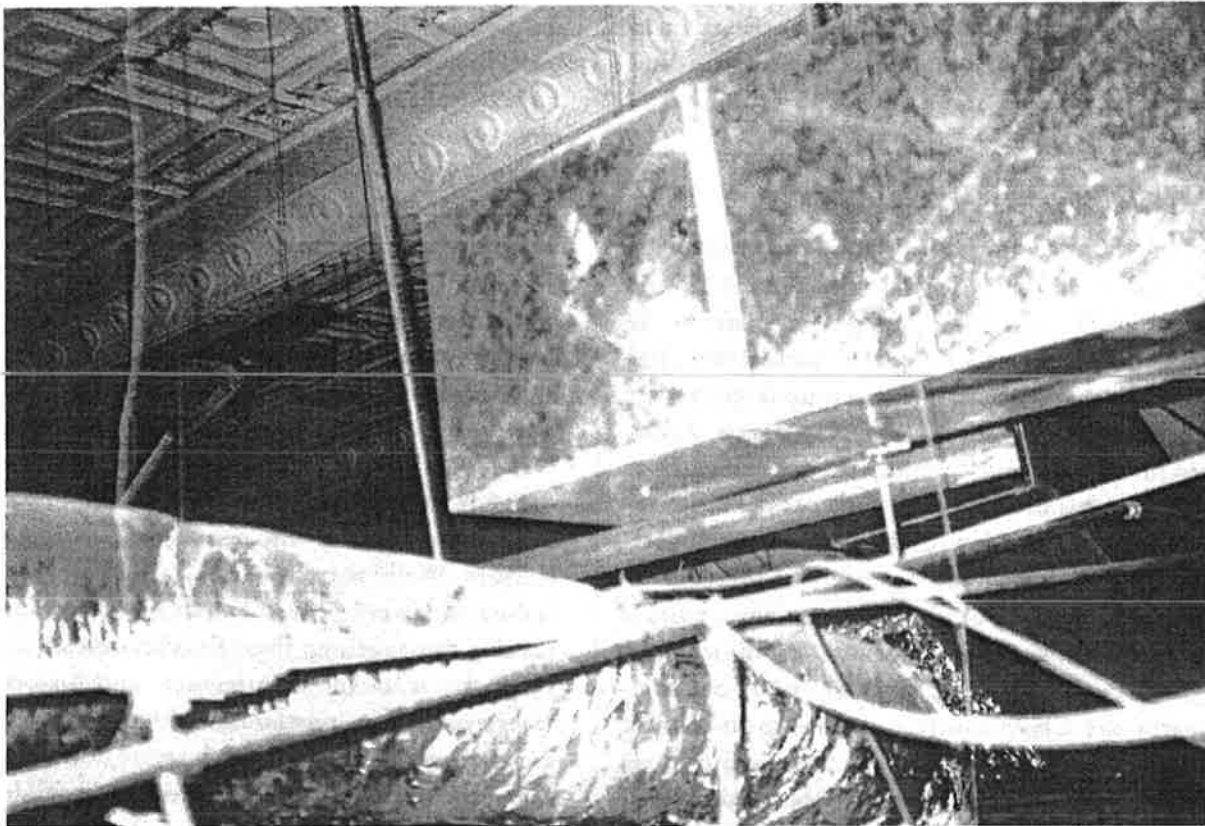
*The historic courtroom ceiling appears to be in fair condition though obscured by a modern systems and a dropped ceiling. (Photo from THC files)*

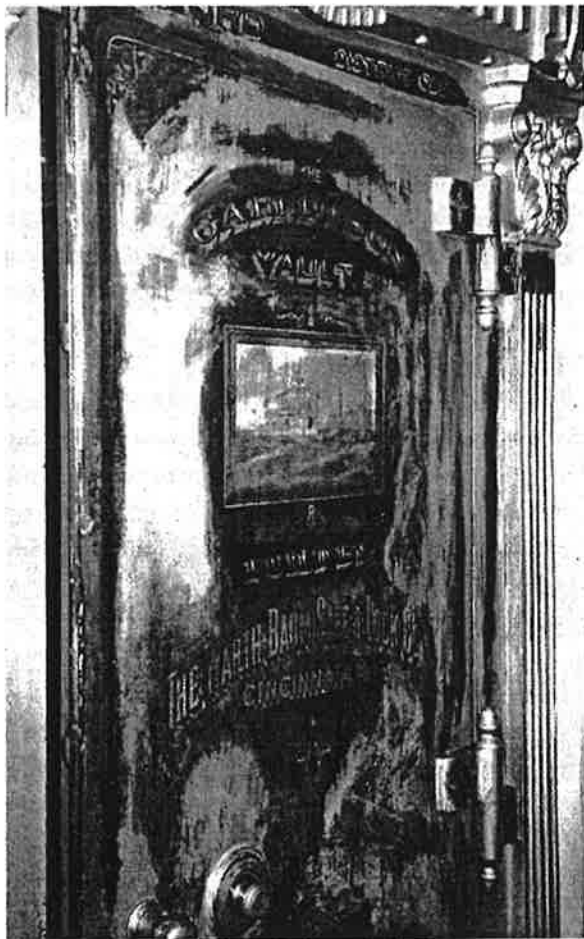
Several original vault doors remain although the decorative paintwork has been painted over. This door has been partially stripped, revealing the beautiful decoration. (Photo from THC files)

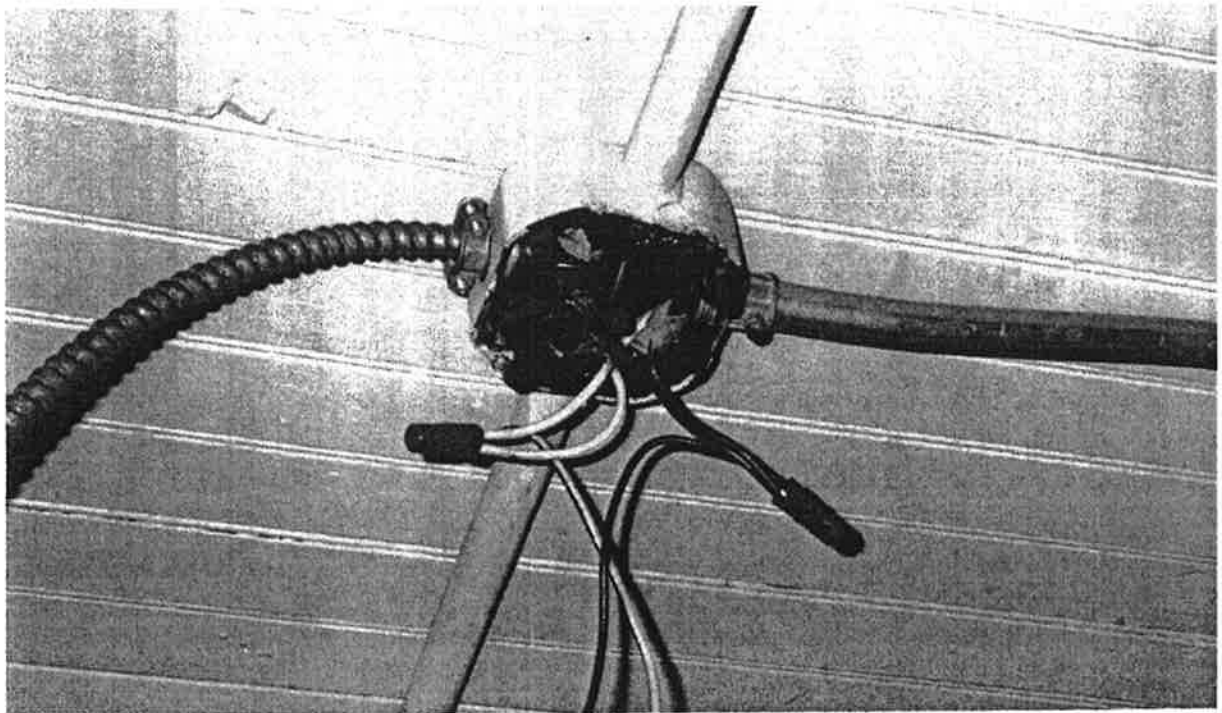
Wiring should be inspected for code deficiencies and repaired. (Photo from THC files)
